**Owasco Watershed Roadside Ditch Assessment
October 2014**

Owasco Lake Watershed Ditch Remediation Sites

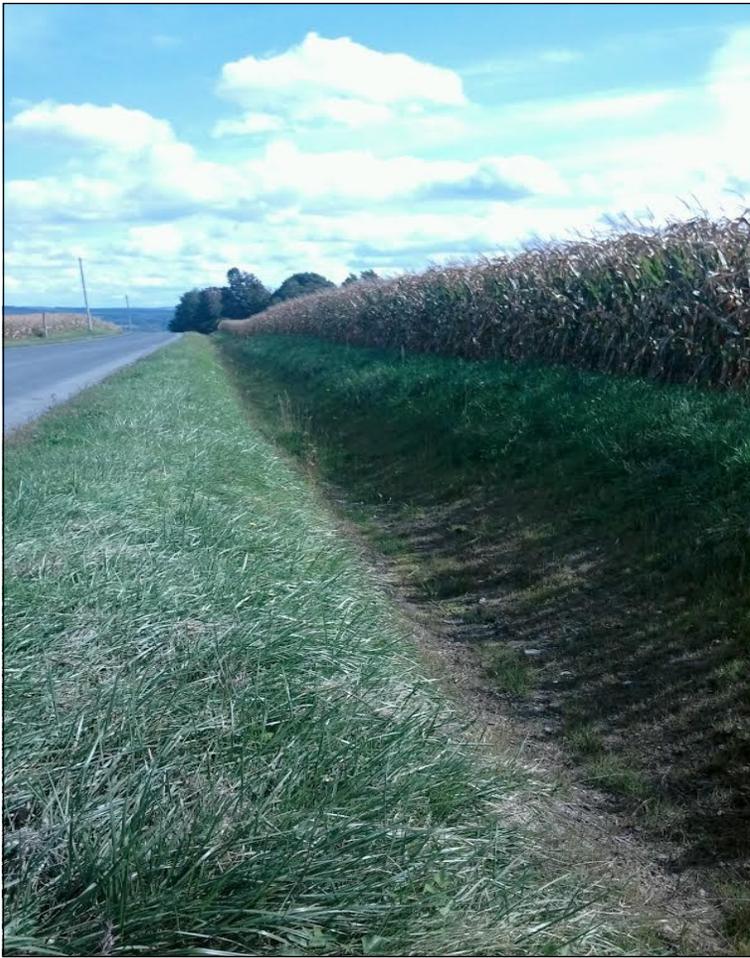
Map Identification	Site 10
Road Name	Sherwood Rd
Town	Scipio
Length of Ditch	5,000 ft
Height/Width of Ditch	2-4/5-10 ft
Percent Vegetation	50%
Ground Type	Soil
Current Condition	Light vegetation, exposed soil and gravel
Sub-Watershed	Unknown
Road Jurisdiction	Cayuga County Highway
Closest Intersection	Sherwood/Wykoff Rd
Rank	Low

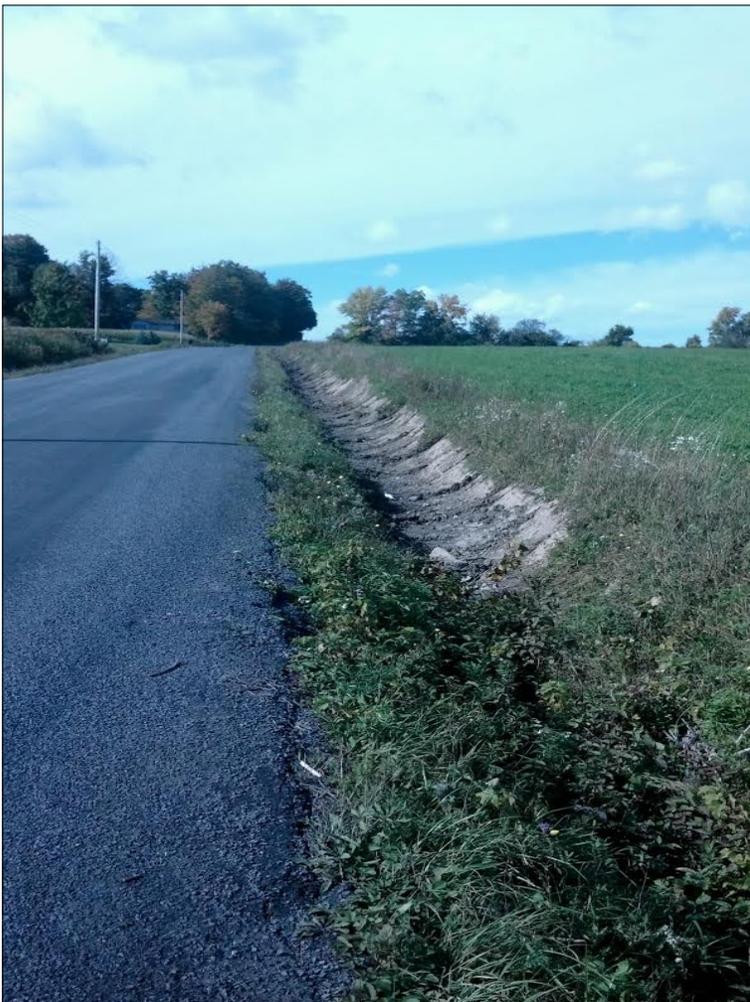
Map Identification	Site 11
Road Name	Hicks Rd
Town	Scipio
Length of Ditch	2,500 ft
Height/Width of Ditch	2-3/4-8 ft
Percent Vegetation	10%
Ground Type	Soil/Gravel
Current Condition	Recently ditched, light vegetation, exposed soil
Sub-Watershed	Unknown
Road Jurisdiction	Town of Scipio
Closest Intersection	Hicks/W Lake Rd
Rank	Moderate

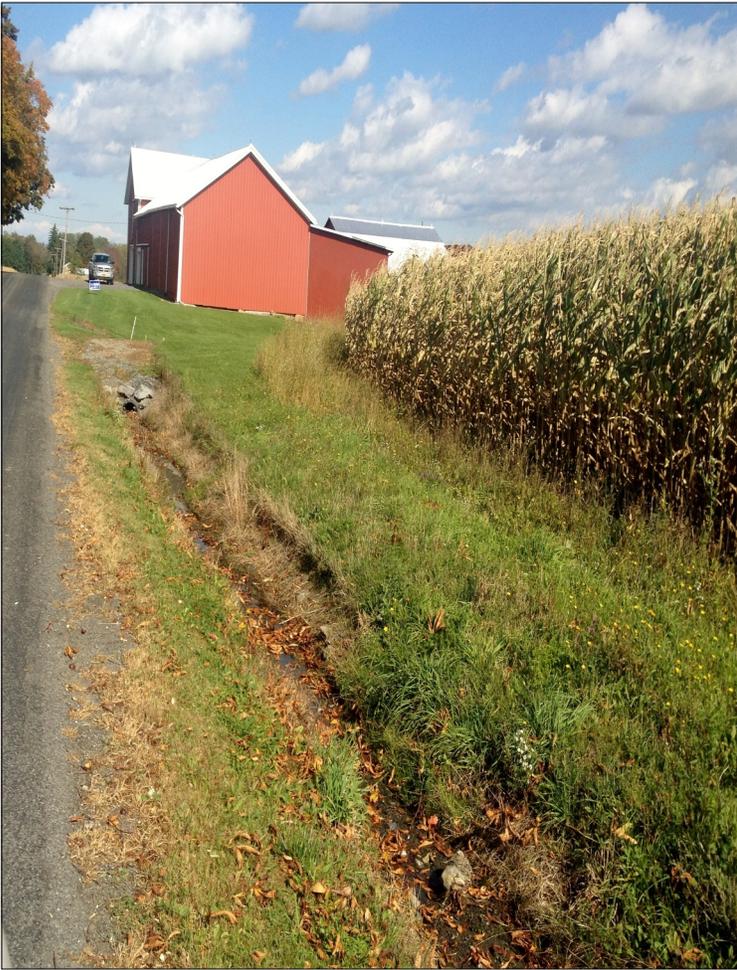
Map Identification	Site 14
Road Name	Wyckoff Rd
Town	Scipio
Length of Ditch	300 ft
Height/Width of Ditch	1-3/2-5 ft
Percent Vegetation	25%
Soil Type	Gravel
Current Condition	Light vegetation/exposed soil and gravel
Sub-Watershed	Unknown
Road Jurisdiction	Cayuga County Highway
Closest Intersection	Wyckoff/Hicks Rd
Rank	Low

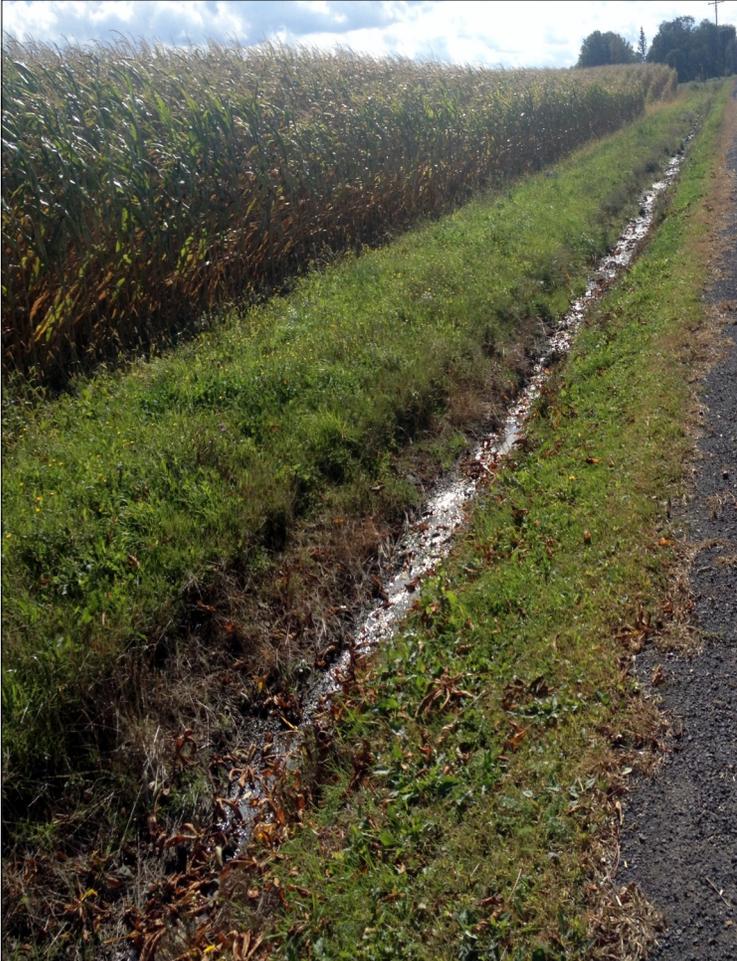
Map Identification	Site 15
Road Name	Center Rd
Town	Scipio
Length of Ditch	300 ft
Height/Width of Ditch	1-3/2-4 ft
Percent Vegetation	25%
Soil Type	Gravel
Current Condition	Light vegetation, exposed soil and gravel
Sub-Watershed	Unknown
Road Jurisdiction	Cayuga County Highway
Closest Intersection	Center/Wyckoff Rd
Rank	Moderate

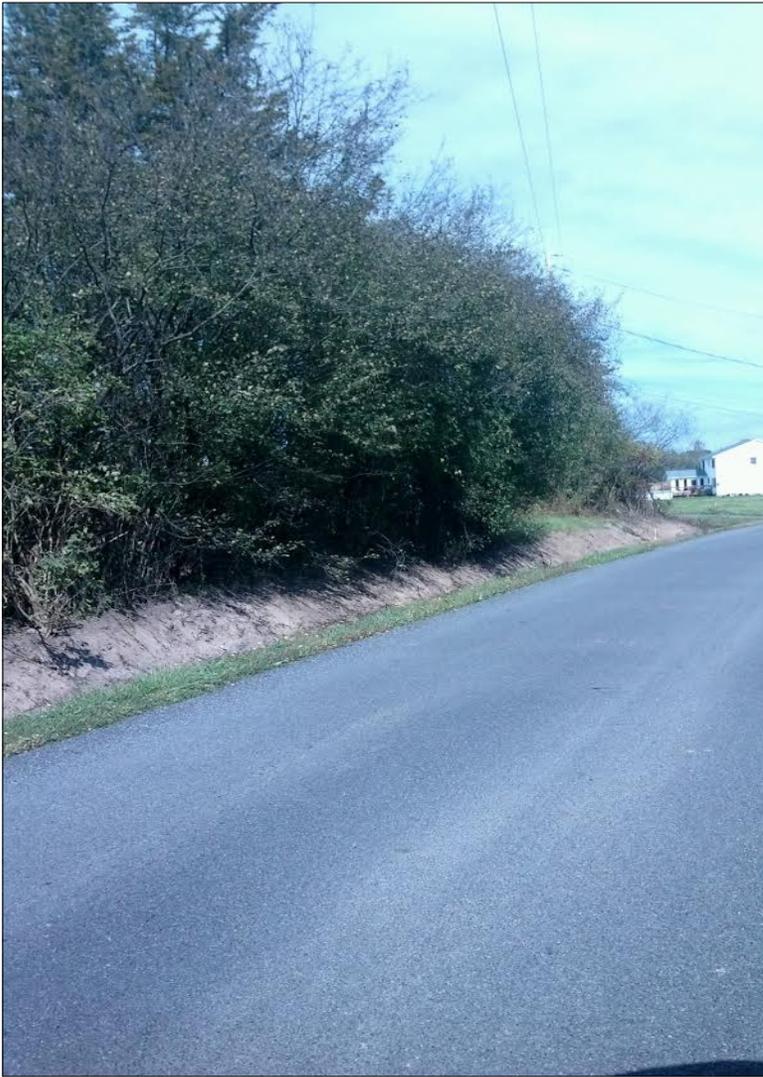
Map Identification	Site 12
Road Name	Mobbs Rd
Town	Fleming
Length of Ditch	2,500 ft
Height/Width of Ditch	1-3/3-6ft
Percent Vegetation	10%
Soil Type	Gravel
Current Condition	Recently ditched, light vegetation, exposed soil
Sub-Watershed	Veness Brook
Road Jurisdiction	Town of Fleming
Closest Intersection	W Lake/Mobbs/ Silver St
Rank	High

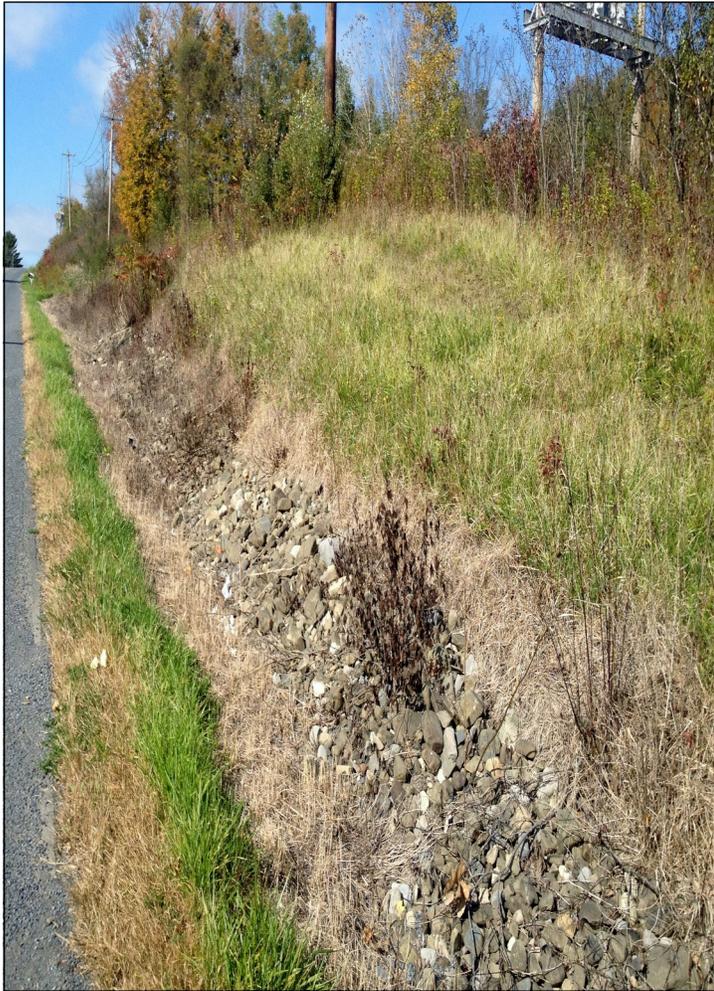
Map Identification	Site 9
Road Name	Cat Path Rd
Town	Locke
Length of Ditch	250 ft
Height/Width of Ditch	2-3/2-3 ft
Percent Vegetation	50%
Soil Type	Stone/Gravel
Current Condition	Vegetation, Herbicide Applied
Sub-Watershed	Owasco Inlet
Road Jurisdiction	Town of Locke
Closest Intersection	Cat Path/Cruthers Rd
Rank	Low

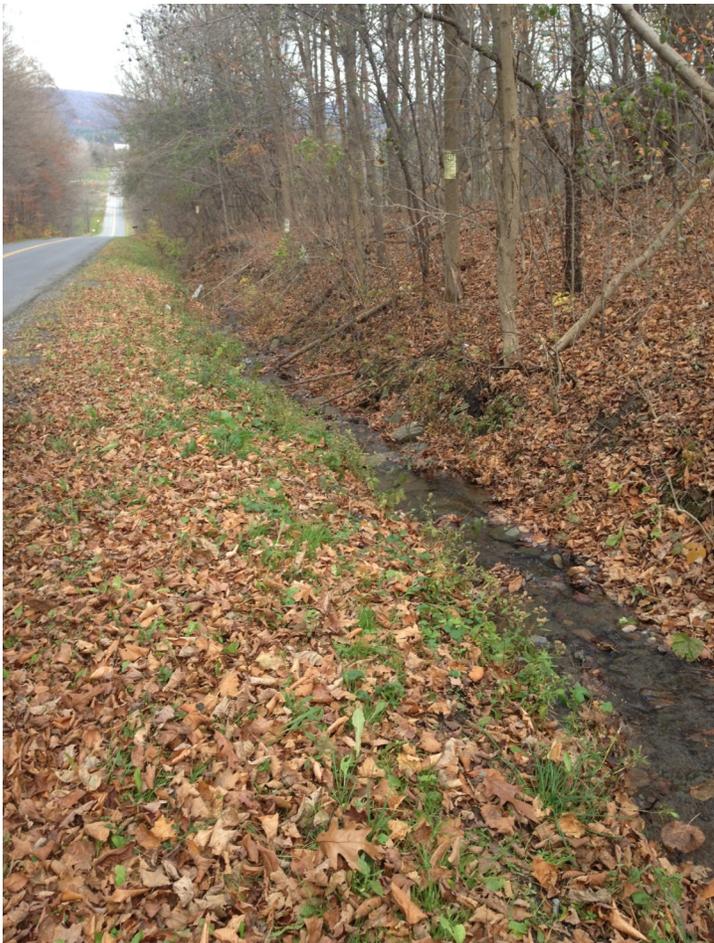
Map Identification	Site 20
Road Name	Bird Cemetery Rd
Town	Locke
Length of Ditch	300 ft
Height/Width of Ditch	3-6/3-6 ft
Percent Vegetation	25%
Soil Type	Soil/Gravel
Current Condition	Light Vegetation, Unstable Soil
Sub-Watershed	Owasco Inlet
Road Jurisdiction	Cayuga County Highway
Closest Intersection	Cat Path/ Bird Cemetery Rd
Rank	High

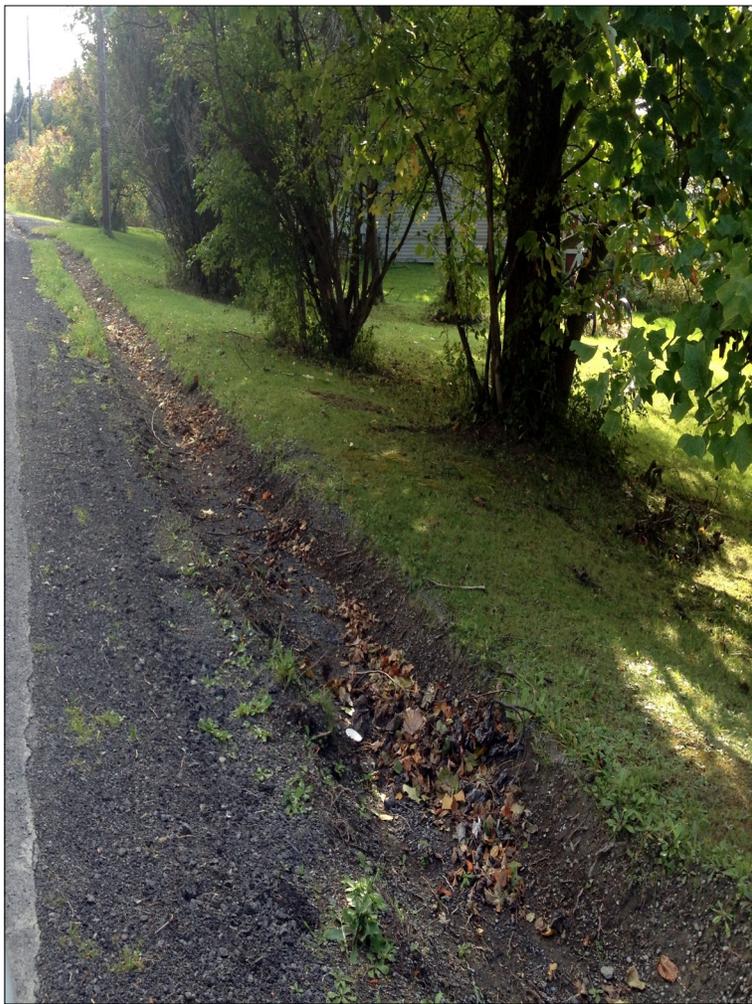
Map Identification	Site 7
Road Name	Skinner Hill Rd
Town	Moravia
Length of Ditch	5,000 ft
Height/Width of Ditch	2-4/3-5 ft
Percent Vegetation	40%
Soil Type	Sand/Gravel
Current Condition	Light vegetation, sections of exposed soil
Sub-Watershed	Unknown
Road Jurisdiction	Town of Moravia
Closest Intersection	Skinner Hill/Harris Rd
Rank	High

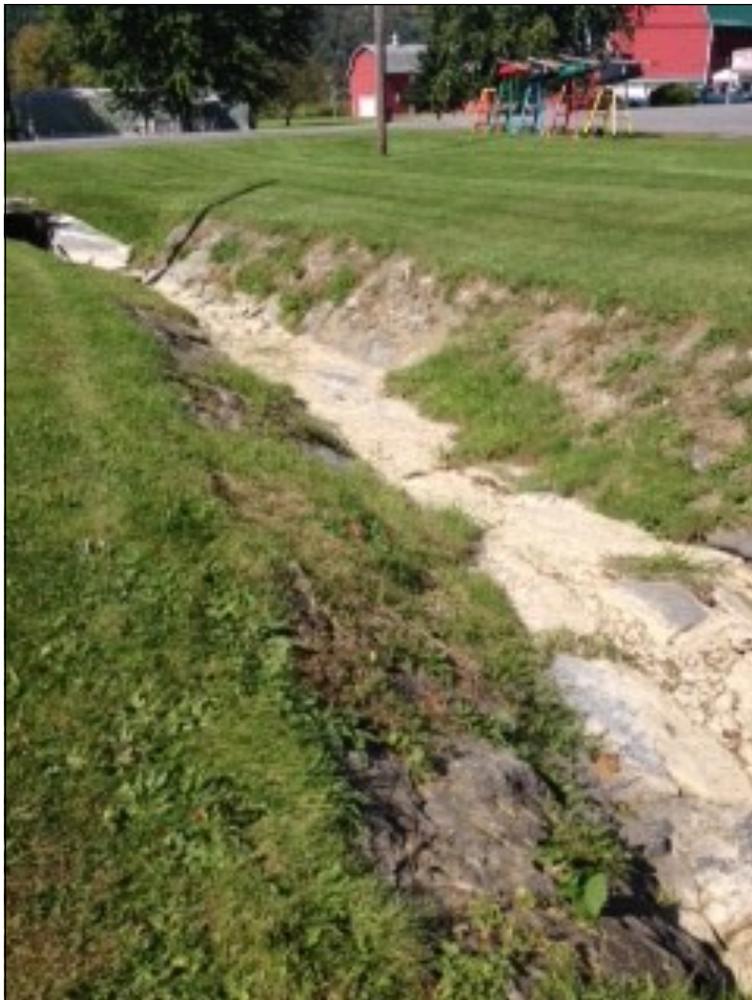
Identification	Site 8
Road Name	Toll Gate Hill Rd
Town	Moravia
Length of Ditch	250 ft
Height/Width of Ditch	2-5/6-12ft
Percent Vegetation	30%
Ground Type	Soil/Gravel
Current Condition	Light vegetation, exposed soil and gravel
Sub-Watershed	Unknown
Road Jurisdiction	Cayuga County Highway
Closest Intersection	Toll Gate Hill/Rt 38
Rank	Moderate

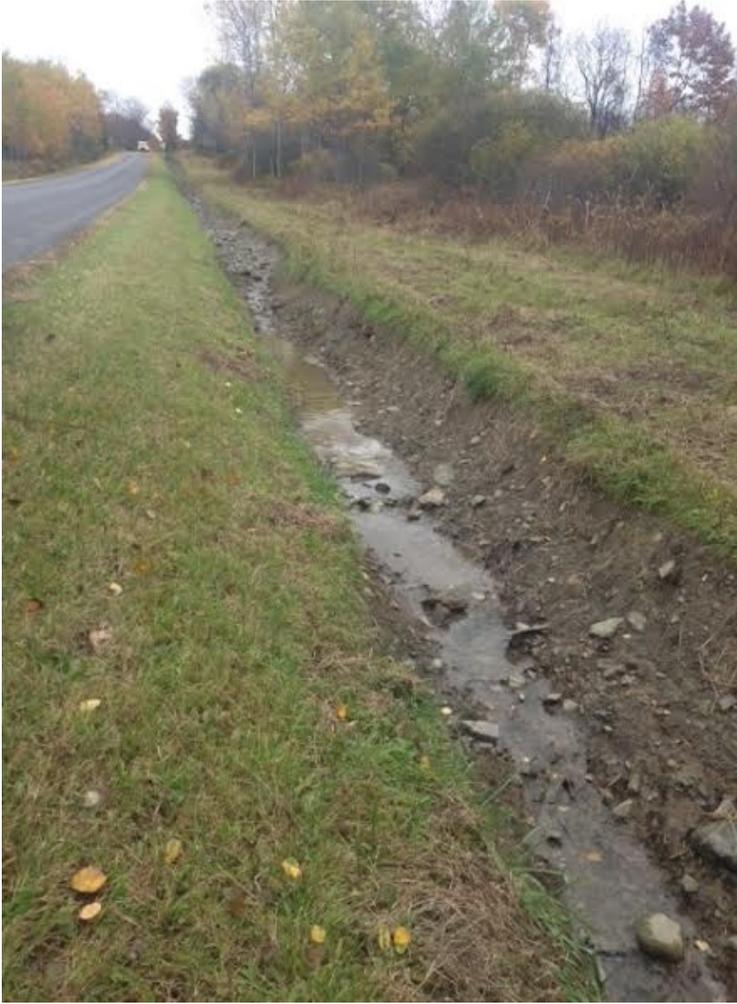
Map Identification	Site 16
Road Name	Brockway Rd
Town	Moravia
Length of Ditch	1,000 ft
Height/Width of Ditch	3-6/4-6 ft
Percent Vegetation	0%
Ground Type	Gravel/Sand
Current Condition	No vegetation, exposed rocks and gravel
Sub-Watershed	Unknown
Road Jurisdiction	Town of Moravia
Closest Intersection	Brockway/Skinner Hill Rd
Rank	High

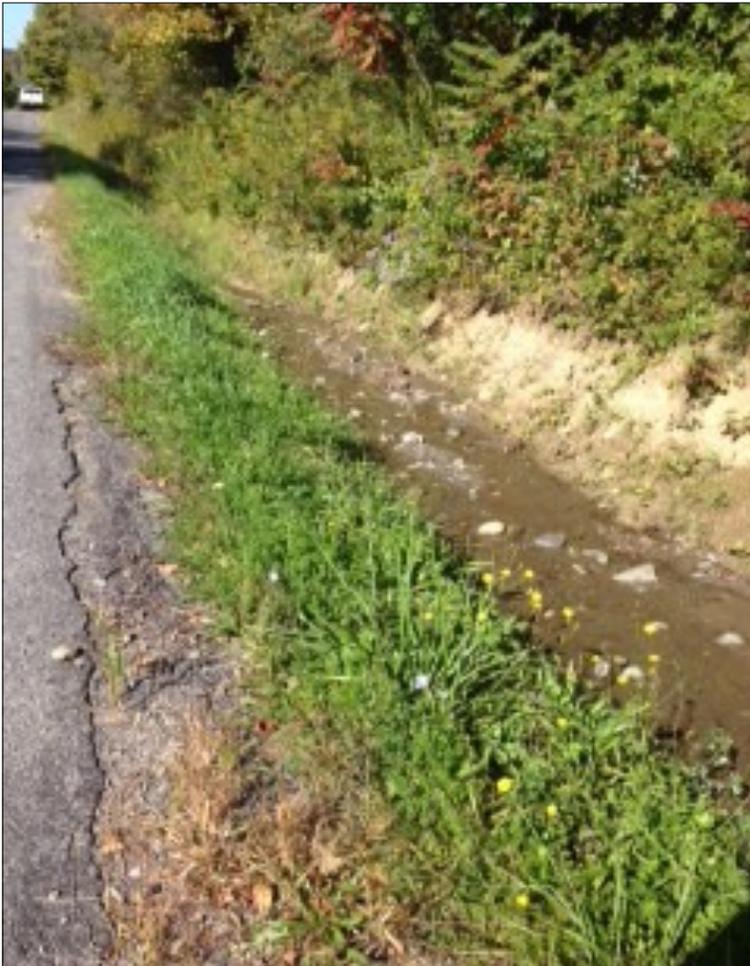
Map Identification	Site 4
Road Name	Cream Hollow Rd
Town	Niles
Length of Ditch	250 ft.
Height/Width of Ditch	2-6/3-7ft.
Percent Vegetation	5%
Ground Type	Soil/Gravel
Current Condition	No vegetation, exposed gravel
Sub-Watershed	Unknown
Road Jurisdiction	Town of Niles
Closest Intersection	Cream Hollow/Rt 38 A
Rank	High

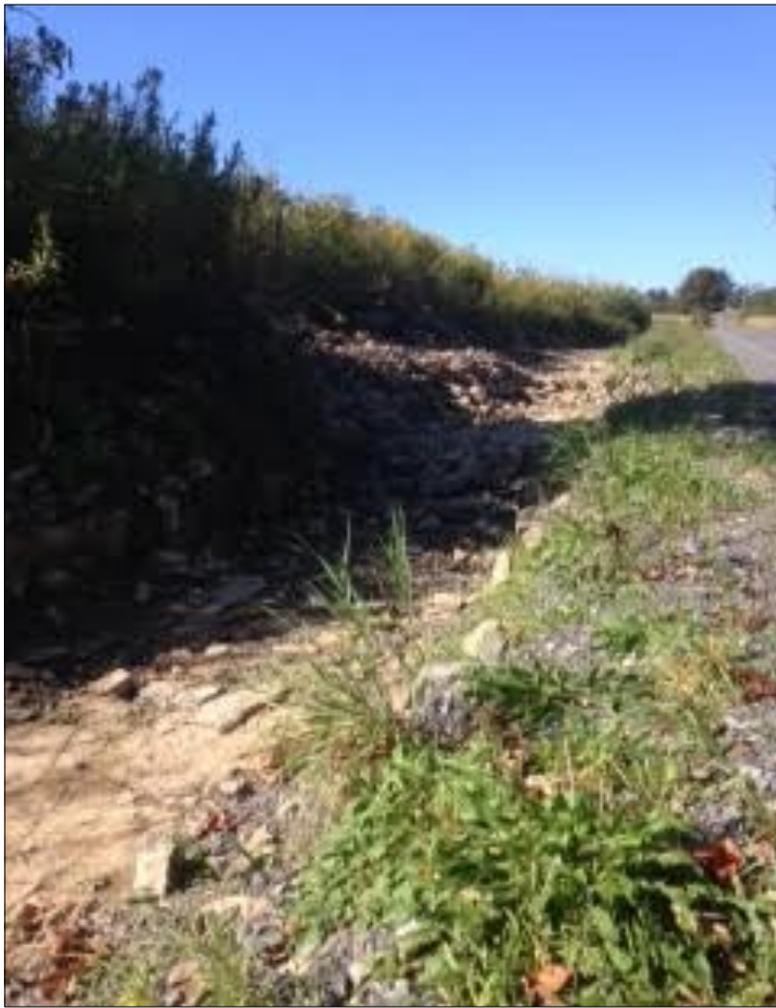
Map Identification	Site 3
Road Name	Split Rock Rd
Town	Niles
Length of Ditch	250 ft.
Height/Width of Ditch	2-6/8-12ft.
Percent Vegetation	0%
Ground Type	Gravel/Rocks
Current Condition	No vegetation, exposed rocks and gravel
Sub-Watershed	Unknown
Road Jurisdiction	Town of Niles
Closest Intersection	Split Rock/ Old Salt Rd
Rank	High

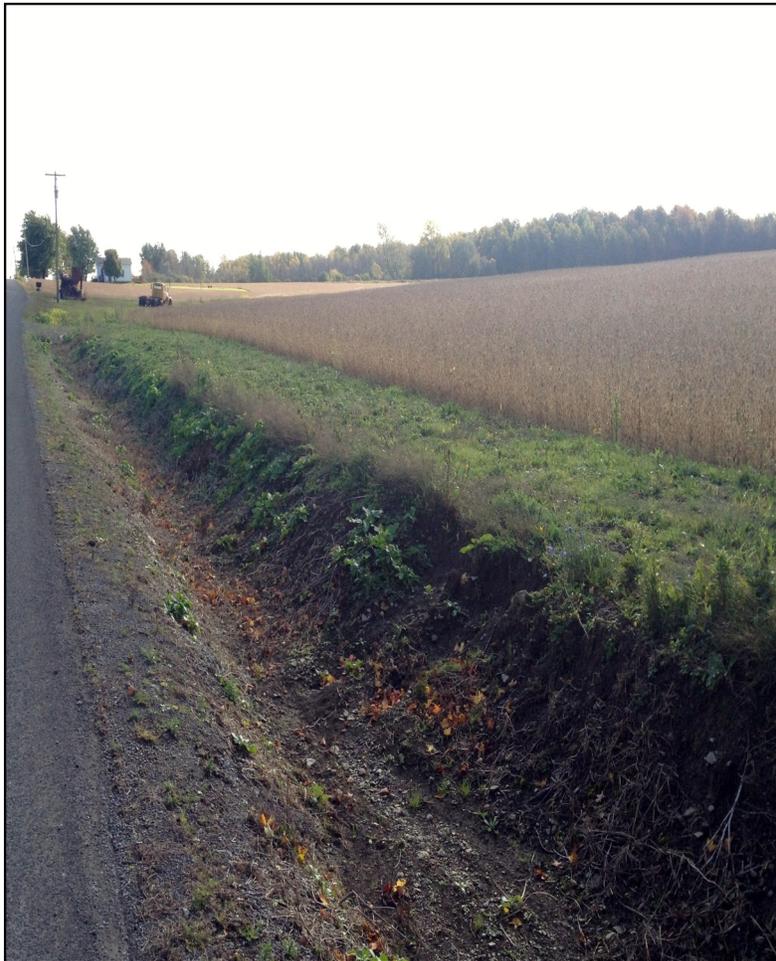
Map Identification	Site 5
Road Name	Derby Rd
Town	Niles
Length of Ditch	2,300 ft
Height/Width of Ditch	2-4/3-6 ft
Percent Vegetation	25%
Soil Type	Sandy Loam
Current Condition	Vegetated, Herbicide Applied
Sub-Watershed	Unknown
Road Jurisdiction	Town of Niles
Closest Intersection	Old Salt/ Derby Rd
Rank	Moderate

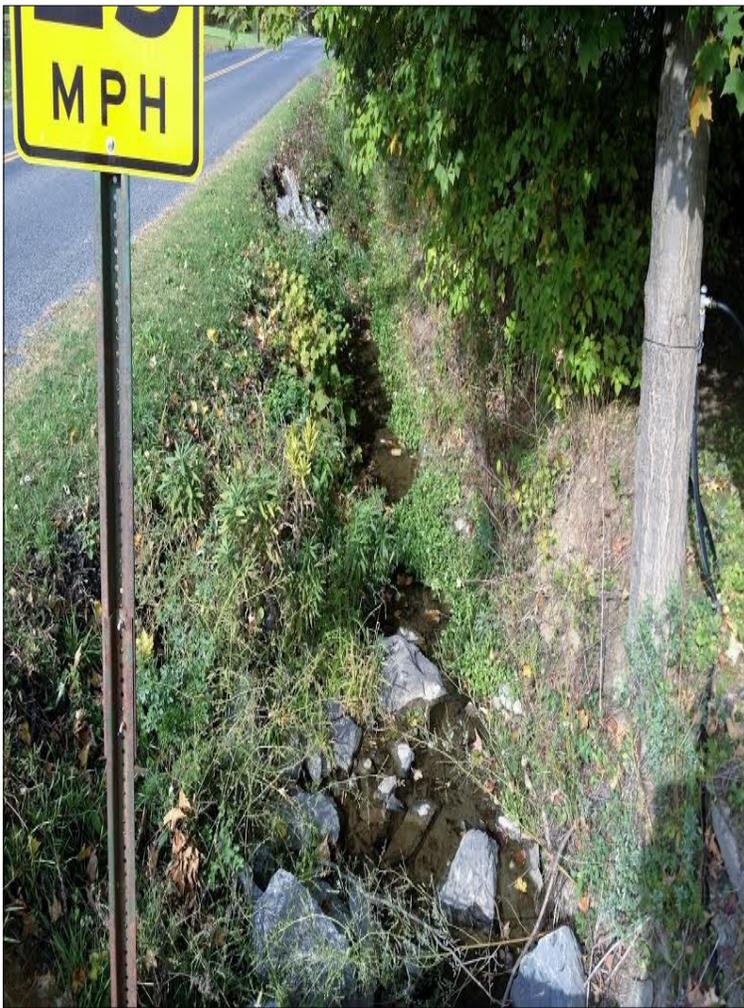
Map Identification	Site 6
Road Name	Globe Rd
Town	Niles
Length of Ditch	1,000 ft
Height/Width of Ditch	2-4/3-6 ft
Percent Vegetation	75%
Soil Type	Soil/Gravel
Current Condition	Vegetation, pesticides applied
Sub-Watershed	Unknown
Road Jurisdiction	Cayuga County Highway
Closest Intersection	Globe/Old Salt Rd
Rank	Low

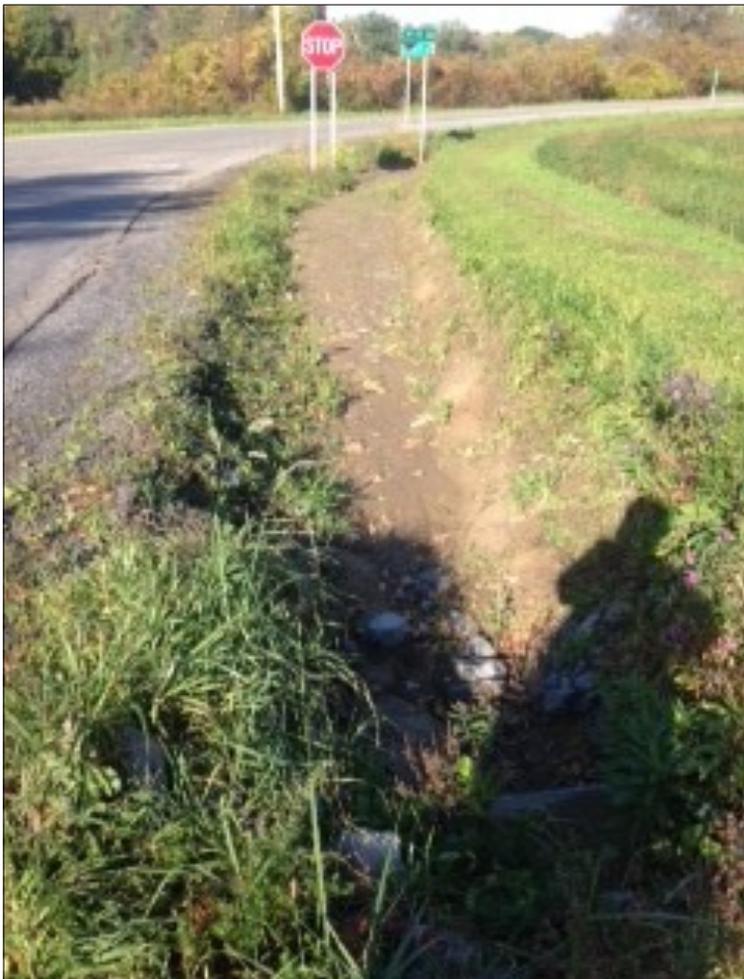
Identification	Site 13
Road Name	Dewitt Rd
Town	Niles
Length of Ditch	1,000 ft
Height/Width of Ditch	3-5/4-7 ft
Percent Vegetation	10%
Ground Type	Soil/Gravel
Current Condition	Exposed soil and gravel, loose rocks
Sub-Watershed	Unknown
Road Jurisdiction	Town of Niles
Closest Intersection	Detwitt/Rt 38 A
Rank	High

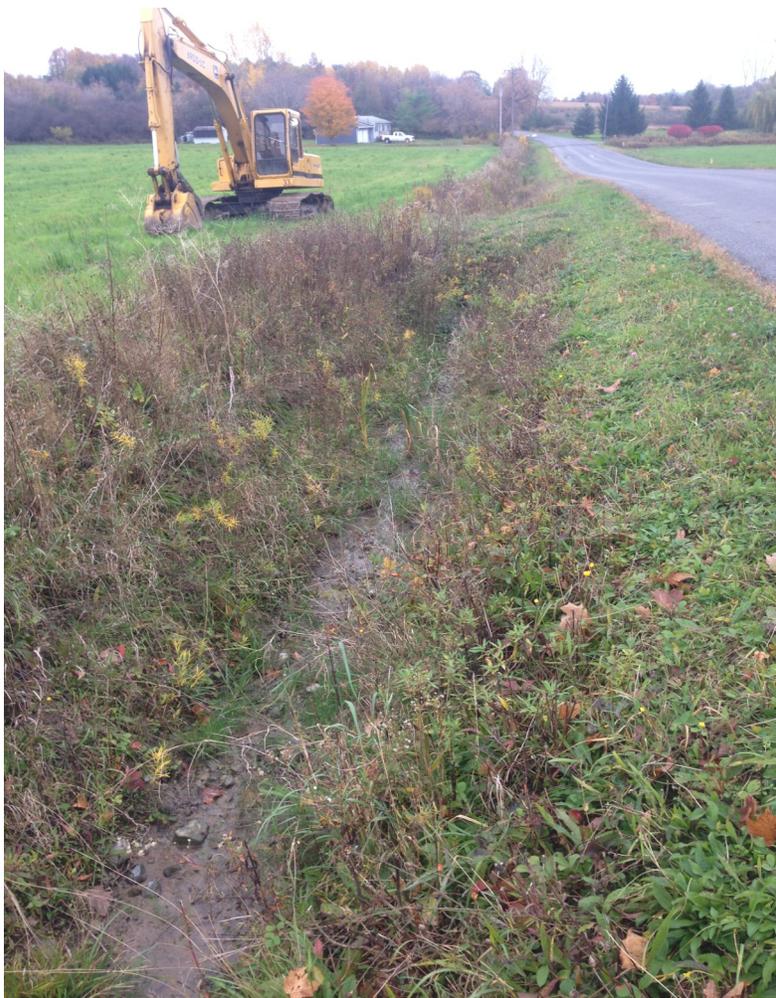
Map Identification	Site 18
Road Name	Sam Adams Ln
Town	Niles
Length of Ditch	100 ft
Height/Width of Ditch	2-3/1-2 ft
Percent Vegetation	75%
Soil Type	Soil/Gravel
Current Condition	Light Vegetation, Sediment Deposition
Sub-Watershed	Unknown
Road Jurisdiction	Cayuga County Highway
Closest Intersection	Sam Adams/Rockefeller Rd
Rank	Low

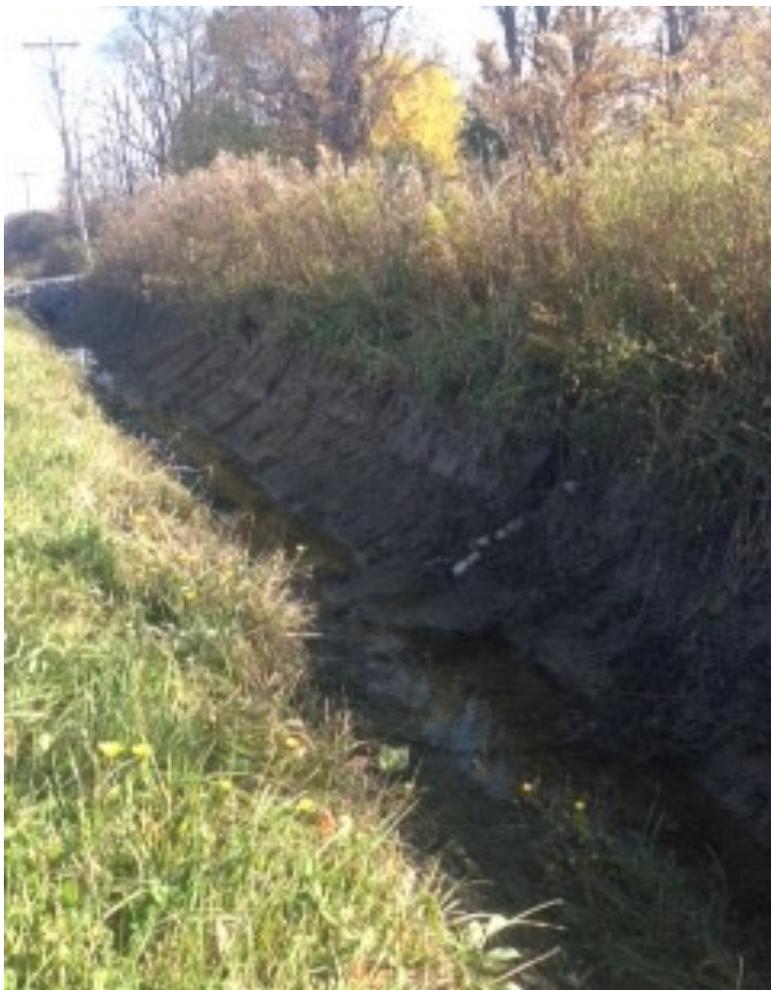
Map Identification	Site 19
Road Name	Harter Rd
Town	Niles
Length of Ditch	100 ft
Height/Width of Ditch	3-4/3-6 ft
Percent Vegetation	25%
Soil Type	Soil/Gravel
Current Condition	Recently Ditched, Light Vegetation
Sub-Watershed	Unknown
Road Jurisdiction	Town of Niles
Closest Intersection	Harter/Fitzpatrick Rd
Rank	Moderate

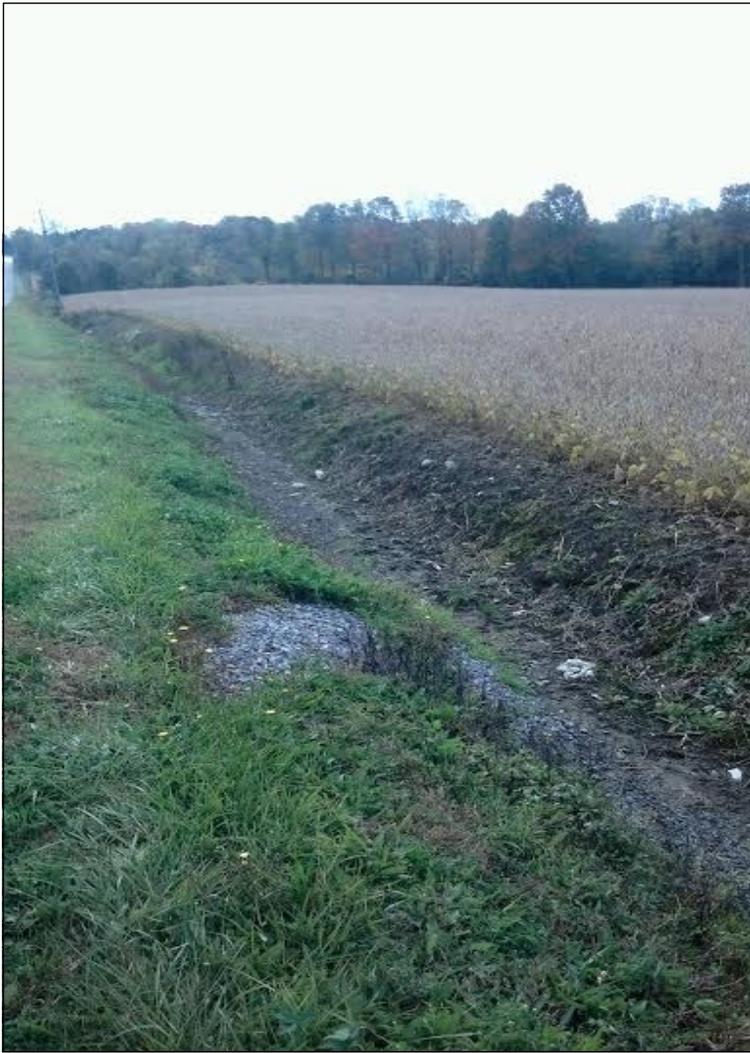
Map Identification	Site 1
Road Name	Melrose Rd
Town	Owasco
Length of Ditch	875 ft.
Height/Width of Ditch	2-3/2-3ft
Percent Vegetation	25%
Soil Type	Sand/Gravel
Current Condition	Light vegetation, exposed soil
Sub-Watershed	Sucker Brook
Road Jurisdiction	Cayuga County Highway
Closest Intersection	Melrose/Broadway Rd
Rank	Low

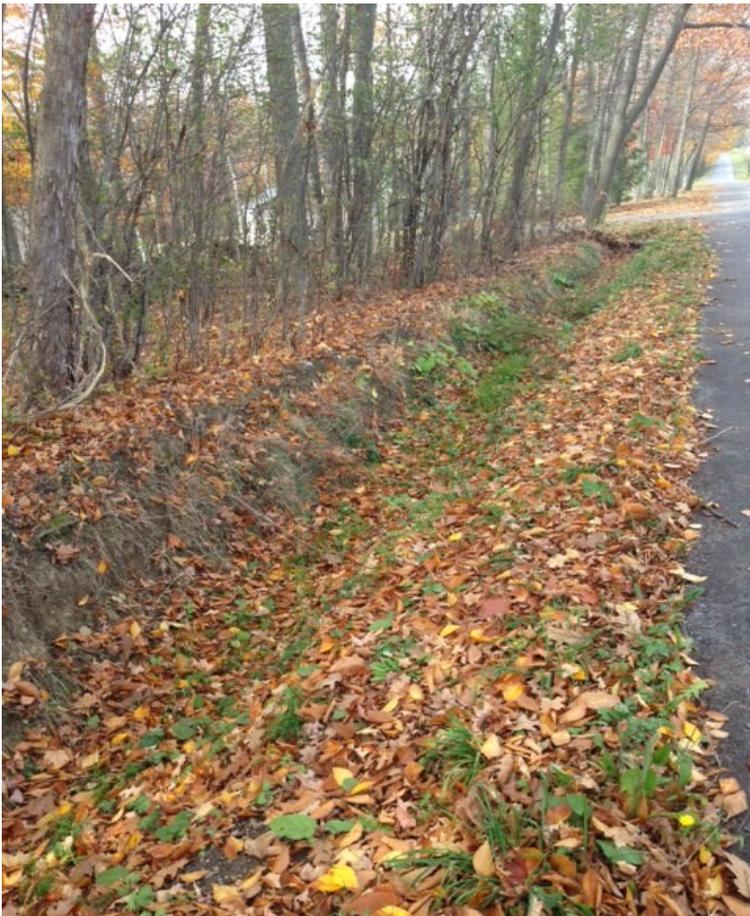
Map Identification	Site 17
Road Name	Cedar Swamp Rd
Town	Owasco
Length of Ditch	500 ft
Height/Width of Ditch	1-4/2-4 ft
Percent Vegetation	25%
Soil Type	Sand/Gravel
Current Condition	Light vegetation, exposed soil
Sub-Watershed	Sucker Brook
Road Jurisdiction	Town of Owasco
Closest Intersection	Cedar Swamp/Town Hall Rd
Rank	Low
