Pollutant mitigation in the ditch network of tributary 46, Owasco Lake, NY

by Nicole C. Pionteck

December 12, 2014

Environmental Science Capstone

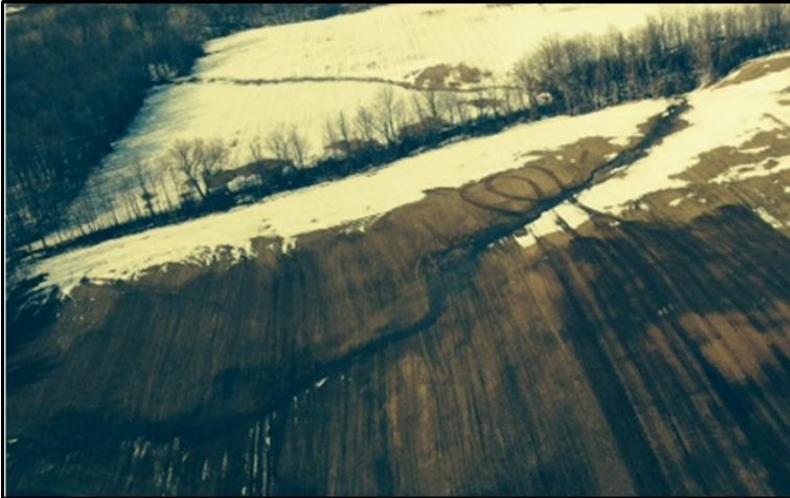
Figure 2. Aerial of a field affected by the runoff event of February 21<sup>st</sup>. Image provided by Cayuga County SWCD.

On February 21, 2014, there was a manure runoff event on the northwest side of the lake. Figure 2 is an aerial image of an agricultural field affected by the event. Manure, containing high amounts of nutrients such as phosphorus, and sediment ran off into the headwaters of nearby tributaries. These tributaries, some of them classified as protected by the Cayuga County Department of Planning, enter the lake directly. Therefore, the manure and sediment exited the mouths' of the tributaries and washed out onto the still ice-covered waters of Owasco Lake (Fig. 3). The cause of this runoff event was a combination of rapid snow melt, heavy rainfall, and poor manure application sites, creating a perfect storm of conditions.

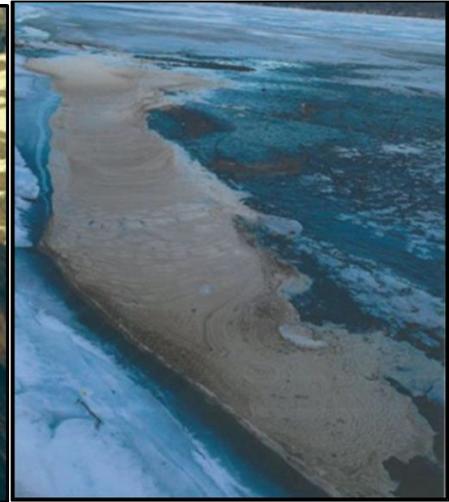
Figure 3. Sediment and manure wash out onto Owasco Lake. Image from the Auburn Citizen.

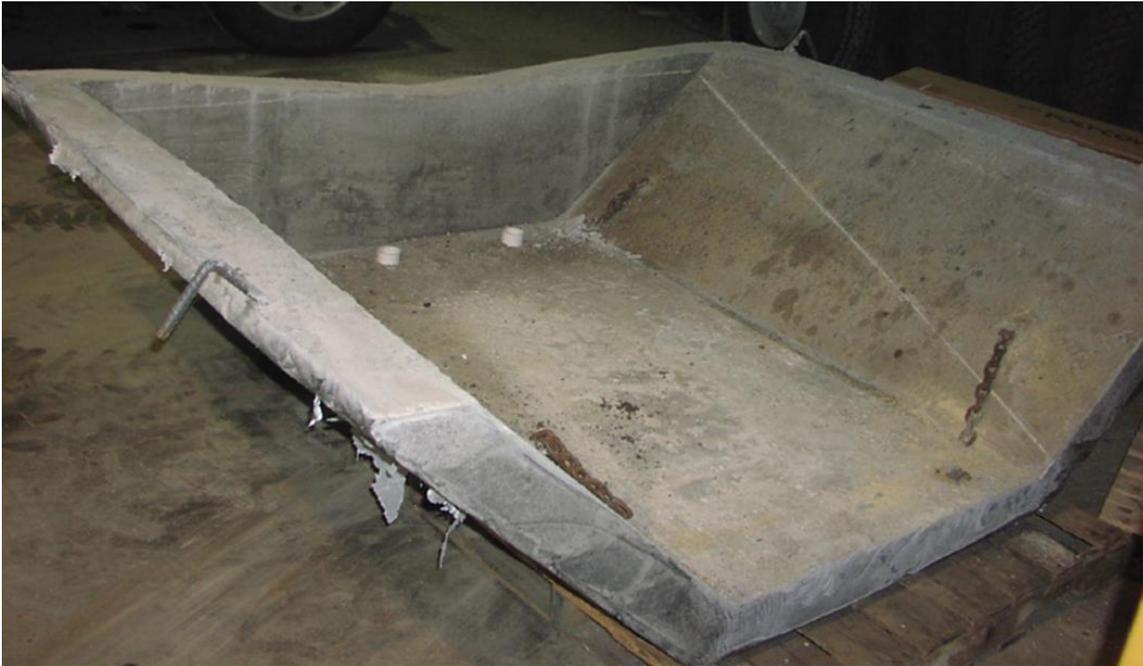
Figure 11. A “build your own” sediment retention basin, created by the Essex County Highway Department (2006).

Figure 9 is a map of the proposed locations for placement of the management practices. The stone check dams (Fig. 10) would be designed based on the specifications in the Vermont Better Back Roads Manual. The ditch located on the map would also have to be redesigned since it is extremely undersized. “Build your own” sediment retention basins would be placed at the location given on the map. The retention basin design is taken from the Essex County Highway Department’s plans (Fig. 11). Figure 12 shows images of the areas where the management practices would be placed.

The concrete sediment retention basin placement is located in a shallow sloped area within the tributary channel. It is an area where two branches of the tributary meet and create a deltaic plain. There is some sediment settling occurring, therefore the retention basin should be installed here as it will be easier to maintain than dredging. The use of the Essex County Highway Department design means the basin can be built to a size that best suits the area. It is cost effective because the frames that the concrete is poured into can be reused for other projects.
