Watershed Community Recognition: Camp

Casowasco

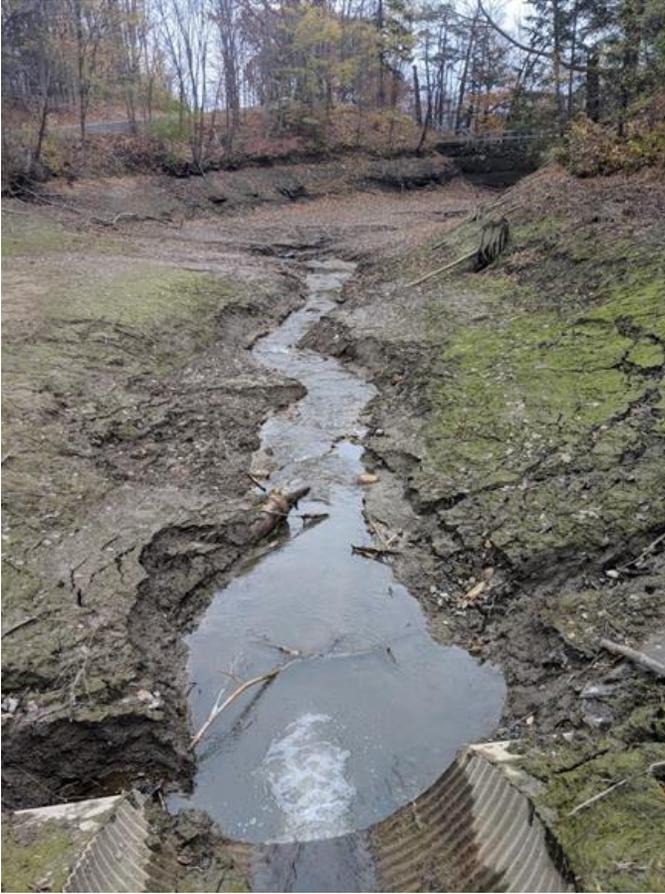
1: Sediment Retention Basin - Before Seeding

Of the water management structures constructed at Casowasco, perhaps the most visible to passersby is the small reservoir located at the camp’s main entrance, adjacent to route 38. The pond, currently empty, was initially constructed by the Case family to function as a control structure to supply water for hydroelectric power generation at their residence on the lake. Through the years, as the need for the on-site hydroelectric diminished, the pond has performed as an effective sediment retention basin, capturing tons of sediment, preventing nutrients and soil from entering the lake. Recently, a mechanical issue with the dam gate drained the pond, revealing the effects of its sediment retention capabilities

(photo). Interim camp director, Anne Horton quickly recognized the exposed material was neither stable material, nor aesthetically pleasing. She decided to add stability and color to the exposed soil by simply broadcast seeding the area with native wildflowers. This small, but important act, will prevent the retained sediment from sliding to the lake until final decisions on maintenance and repair of the structure are agreed on.

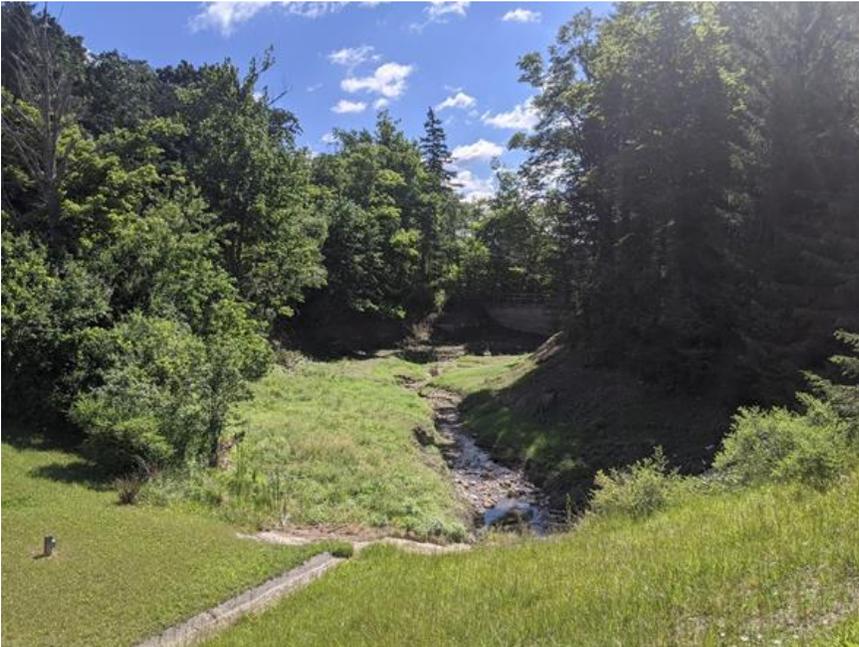
2: Sediment Retention Basin - After Seeding
