Owasco Lake Watershed 2017 Roadside Ditch Assessment

Road Ditch Assessment Sites in Moravia (Cayuga County)

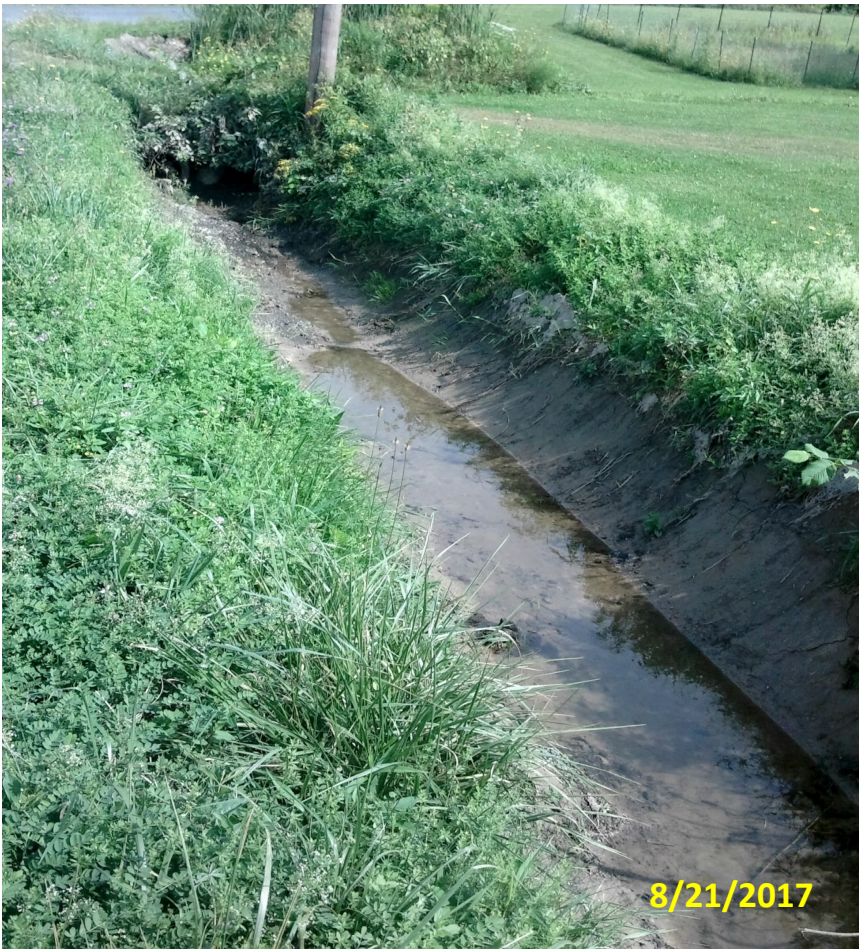
Map Identifier: Site 66
Sub-watershed: Firelane 33
Tributary
Road Name: Rockefeller Road
Town: Moravia
Road Jurisdiction: Cayuga County
Highway
Closest Intersection: Rockefeller Road/Hall Road
Direct connection or proximity to a stream?: Yes
Percent Vegetation & Type: 25% Grasses
Level of Erodibility: Moderate
Slope of Area: Moderate Grade
Length of Ditch: 300 ft
Management Recommended: Hydroseeding
Resolvability: Moderate

Rank: High (Score = 45)
Estimated Cost: \$450

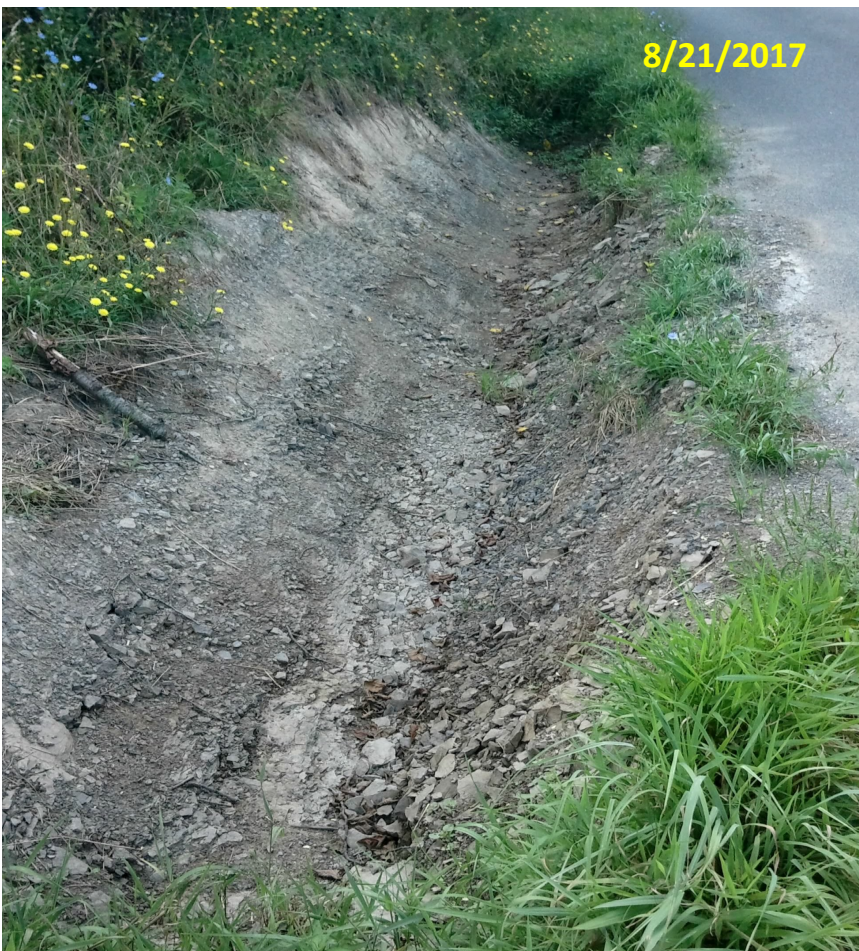
Map Identifier: Site 67
Sub-watershed: Unknown
Road Name: Rockefeller Road
Town: Moravia
Road Jurisdiction: Cayuga County
Highway
Closest Intersection: Rockefeller Road/Angling Road
Direct connection or proximity to a stream?: No
Percent Vegetation & Type: 20% Grasses
Level of Erodibility: Moderate
Slope of Area: Moderate Grade
Length of Ditch: 50 ft
Management Recommended: Hydroseeding
Resolvability: Moderate

Rank: Moderate (Score = 30)
Estimated Cost: \$75
Comments: Near Fire Lane 35

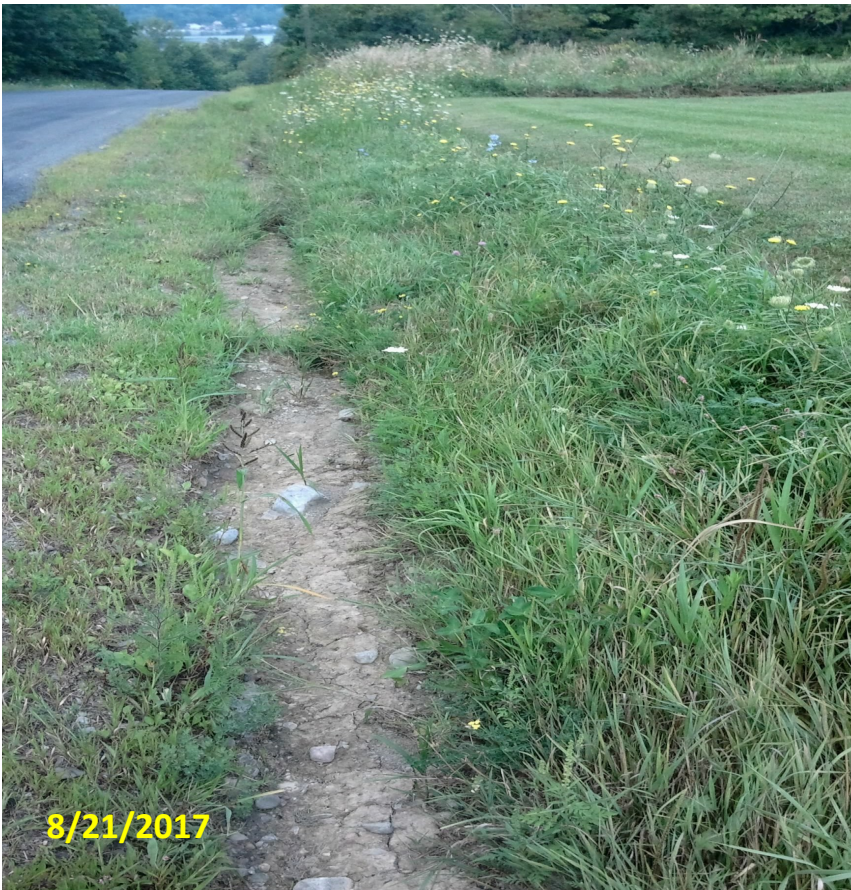
Map Identifier: Site 68
Sub-watershed: Owasco Inlet
Road Name: Riley Road
Town: Moravia
Road Jurisdiction: Town of Moravia
Closest Intersection: Riley Road/
Angling Road
Direct connection or proximity to a stream?: No
Percent Vegetation & Type: 50%
Grasses
Level of Erodibility: Moderate
Slope of Area: Steep Grade
Length of Ditch: 800 ft
Management Recommended:
Hydroseeding
Resolvability: Simple

Rank: High (Score = 40)
Estimated Cost: \$1,200

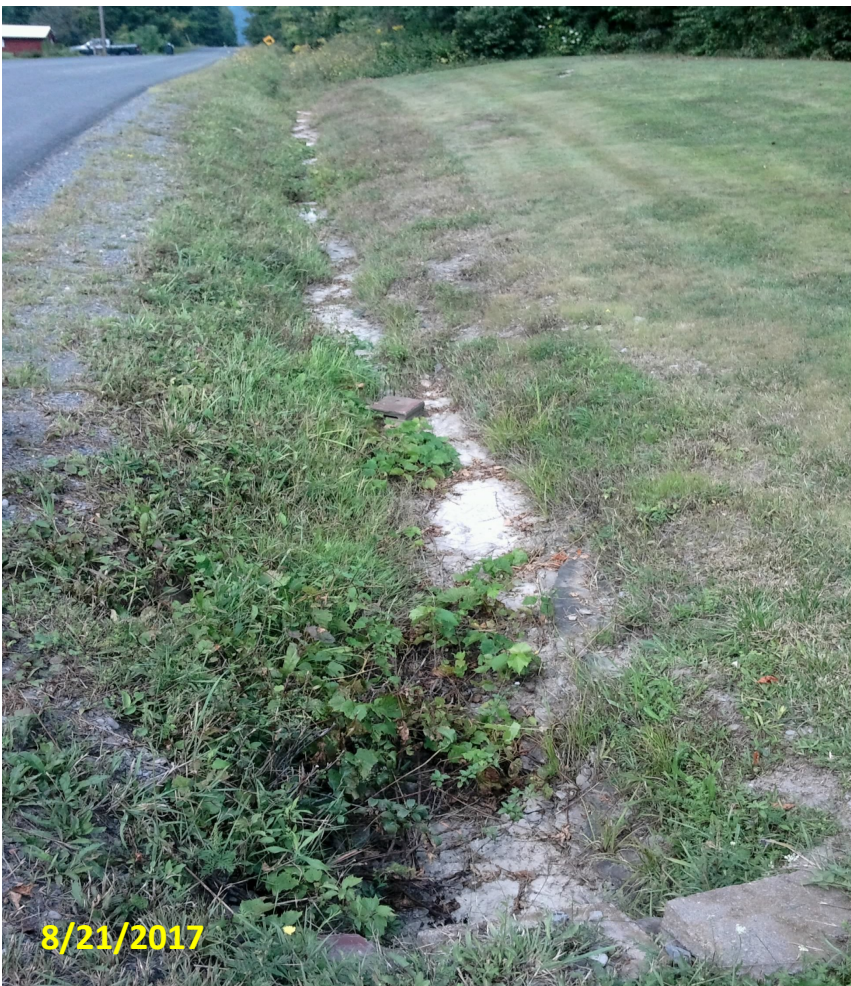
Map Identifier: Site 69
Sub-watershed: Owasco Inlet
Road Name: Riley Road
Town: Moravia
Road Jurisdiction: Town of Moravia
Closest Intersection: Riley Road/
Oak Hill Road
Direct connection or proximity to a stream?: Yes
Percent Vegetation & Type: 75%
Grasses
Level of Erodibility: Moderate
Slope of Area: Moderate Grade
Length of Ditch: 250 ft
Management Recommended:
Hydroseeding
Resolvability: Simple

Rank: Moderate (Score = 35)
Estimated Cost: \$375
Comments: Concrete at bottom of
ditch

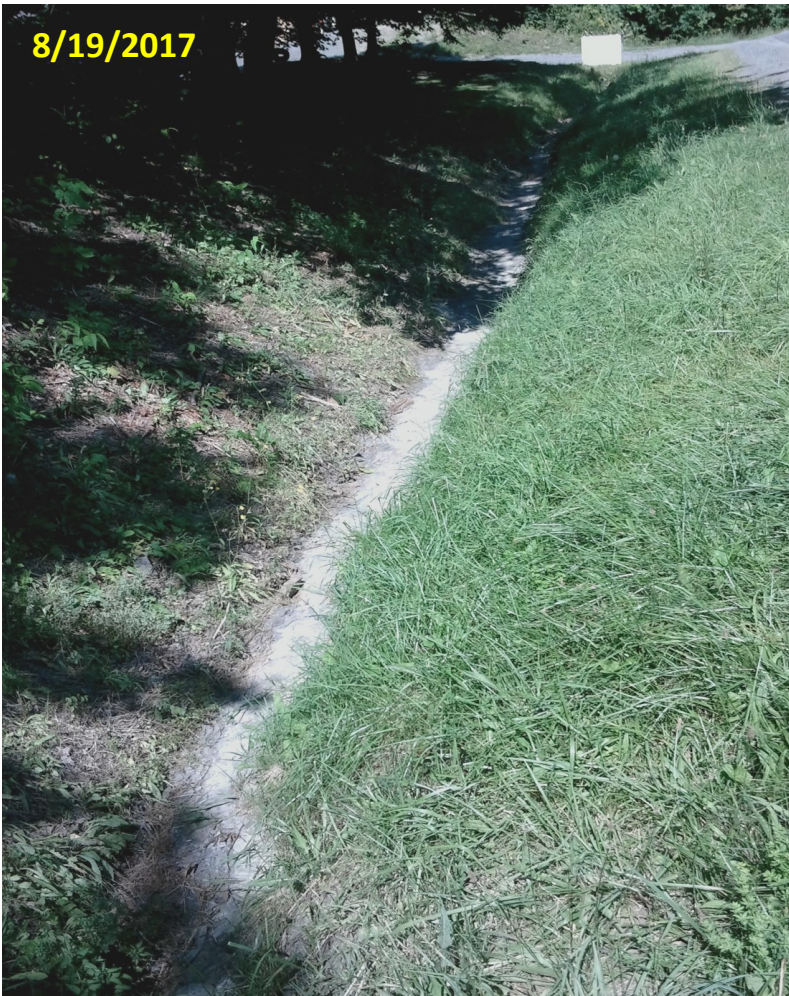
Map Identifier: Site 70

Direct connection or proximity to a stream?: Yes

Percent Vegetation & Type: 60% Grasses

Level of Erodibility: Moderate

Slope of Area: Steep Grade

Length of Ditch: 700 ft

Rank: High (Score = 45)

Comments: Solid rock at bottom of ditch

Management Recommended:
Hydroseeding

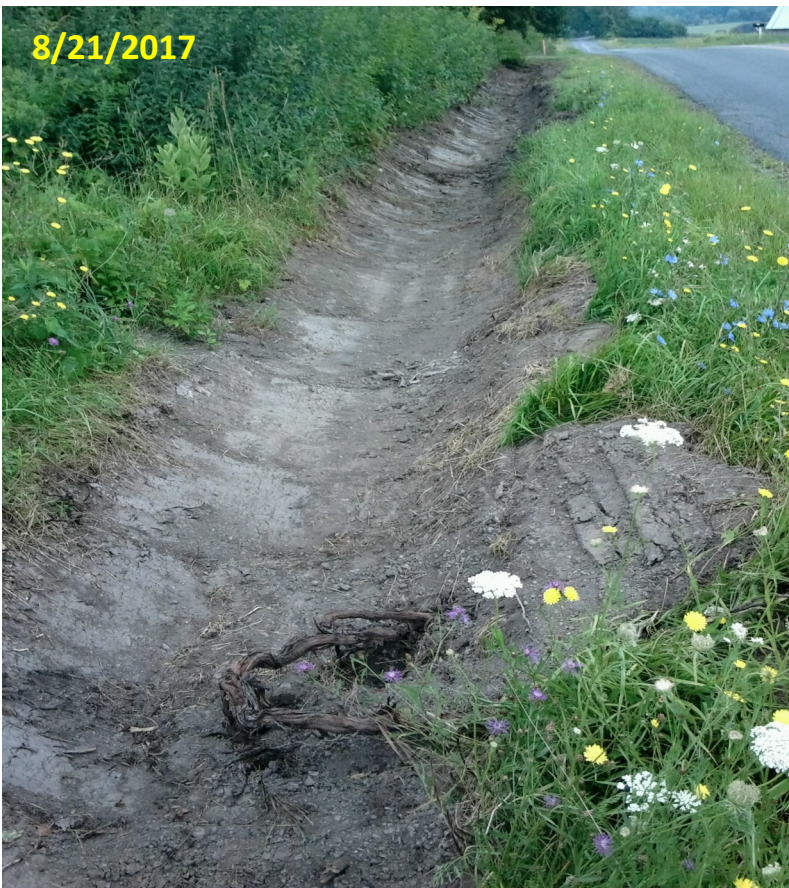
Map Identifier: Site 71

Direct connection or proximity to a stream?: No

Percent Vegetation & Type: 5% Grasses

Level of Erodibility: Moderate

Slope of Area: Moderate Grade

Length of Ditch: 200 ft

Rank: Moderate (Score = 35)

Management Recommended:
Hydroseeding

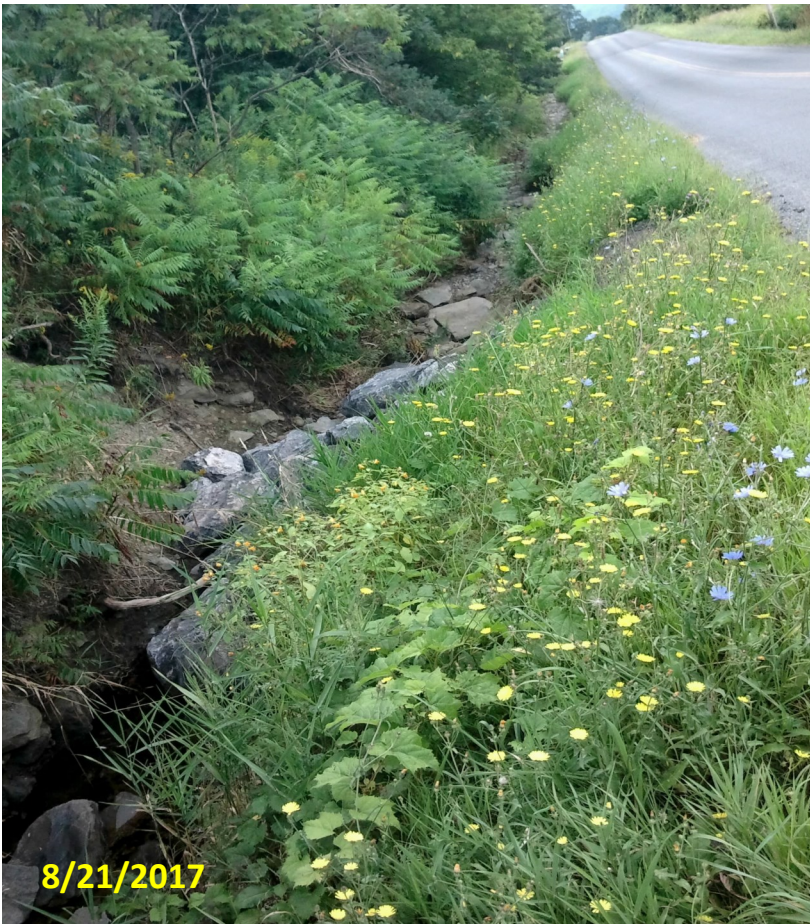
Map Identifier: Site 72
Sub-watershed: Owasco Inlet
Road Name: Oak Hill Road
Town: Moravia
Road Jurisdiction: Cayuga County Highway
Closest Intersection: Oak Hill Road/ North Main Street
Direct connection or proximity to a stream?: No
Percent Vegetation & Type: 50% Woody Shrubs
Level of Erodibility: High
Slope of Area: Steep Grade
Length of Ditch: 3,150 ft
Management Recommended: Rock Armor
Resolvability: Moderate

Rank: High (Score = 50)
Estimated Cost: \$4,725

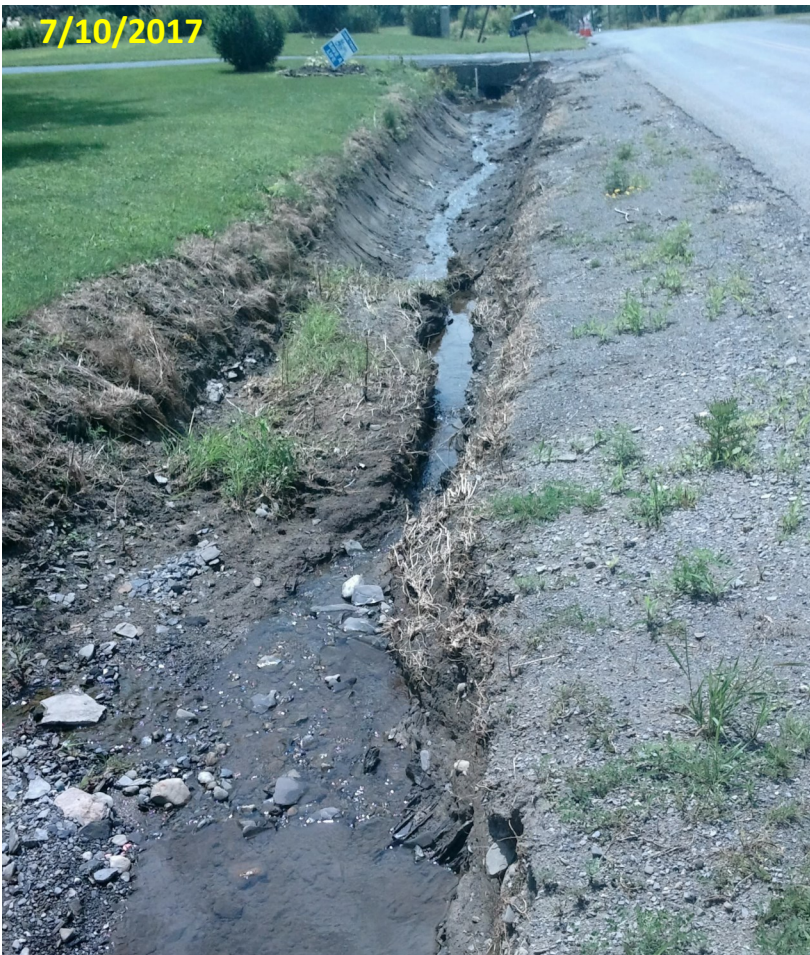
Map Identifier: Site 73
Sub-watershed: Owasco Inlet
Road Name: Oak Hill Road
Town: Moravia
Road Jurisdiction: Cayuga County Highway
Closest Intersection: Oak Hill Road/ North Main Street
Direct connection or proximity to a stream?: No
Percent Vegetation & Type: 5% Grasses
Level of Erodibility: High
Slope of Area: Moderate Grade
Length of Ditch: 150 ft
Management Required: Rock Armor
Resolvability: Moderate

Rank: Moderate (Score = 35)
Estimated Cost: \$225
Comments: Post-storm damage

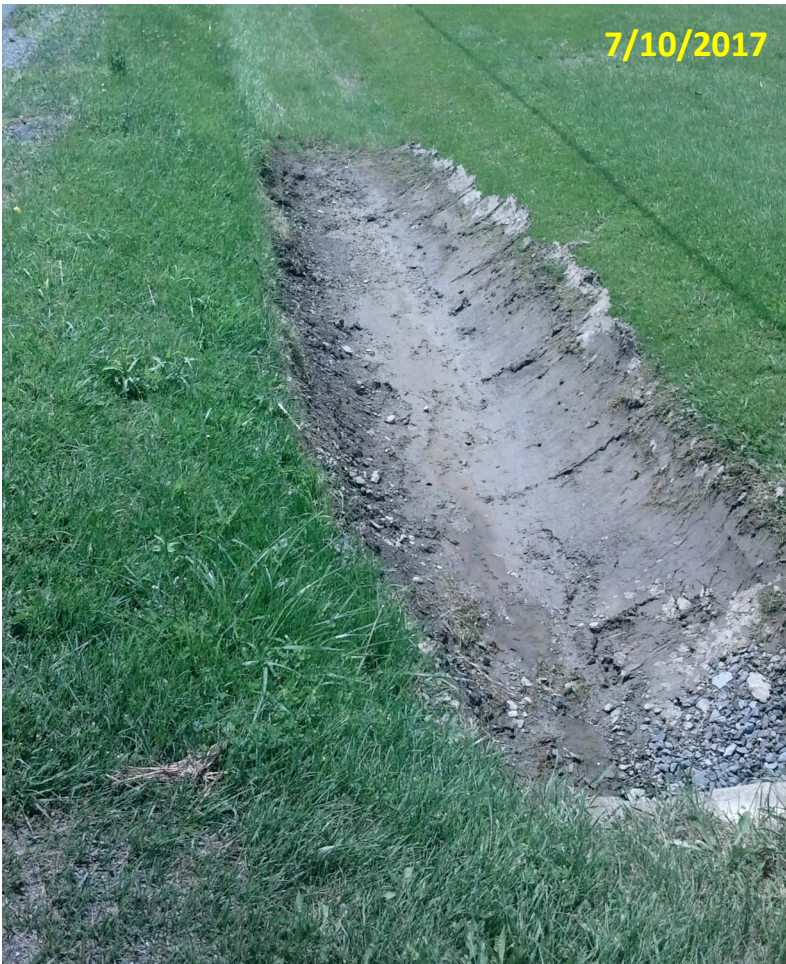
Map Identifier: Site 74
Sub-watershed: Owasco Inlet
Road Name: Oak Hill Road
Town: Moravia
Road Jurisdiction: Cayuga County Highway
Closest Intersection: Oak Hill Road/North Main Street
Direct connection or proximity to a stream?: No
Percent Vegetation & Type: 0%
Level of Erodibility: Moderate
Slope of Area: Moderate Grade
Length of Ditch: 250 ft
Management Recommended: Hydroseeding
Resolvability: Simple

Rank: Moderate (Score = 35)
Estimated Cost: \$375
Comments: Ditch split into several segments

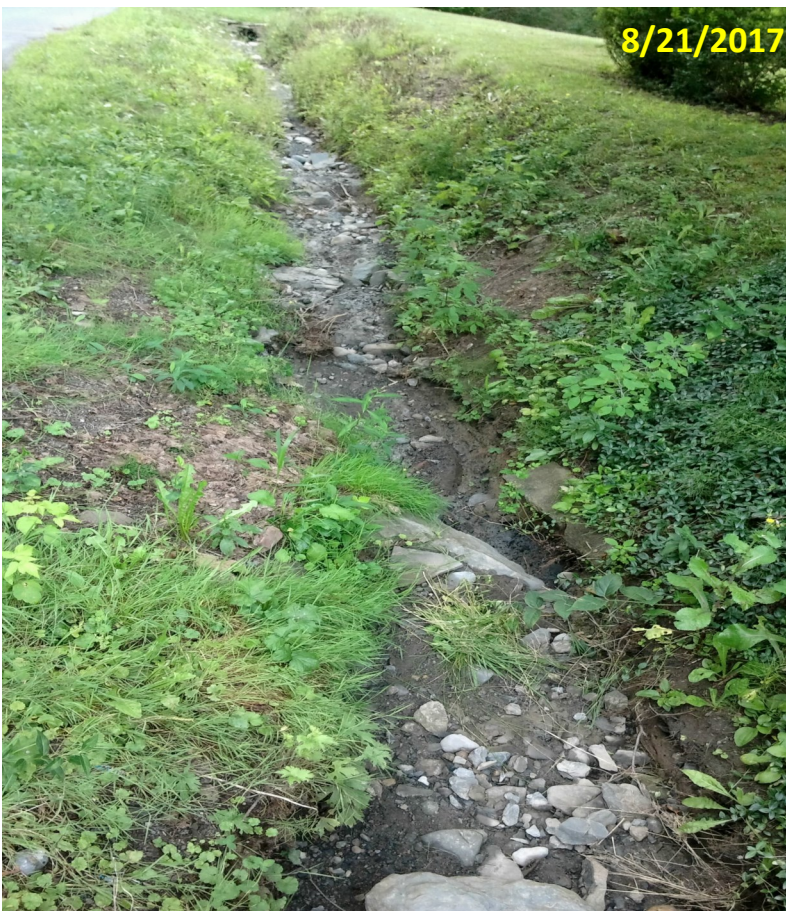
Map Identifier: Site 75
Sub-watershed: Owasco Inlet
Road Name: Oak Hill Road
Town: Moravia
Road Jurisdiction: Cayuga County Highway
Closest Intersection: Oak Hill Road/North Main Street
Direct connection or proximity to a stream?: No
Percent Vegetation & Type: 60% Grasses
Level of Erodibility: Moderate
Slope of Area: Steep Grade
Length of Ditch: 50 ft
Management Recommended: Hydroseeding
Resolvability: Simple

Rank: Moderate (Score = 30)
Estimated Cost: \$75
Comments: Culvert in deteriorating condition

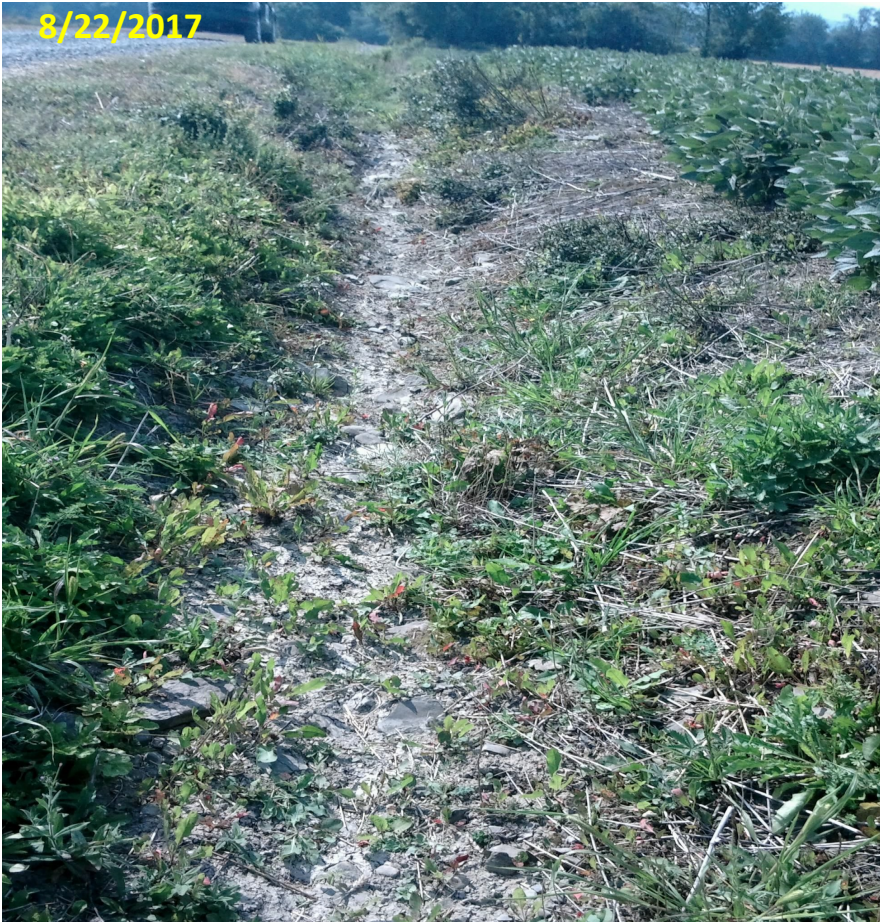
Map Identifier: Site 76
Sub-watershed: Decker Creek
Road Name: Church Road
Town: Moravia
Road Jurisdiction: Town of Moravia
Closest Intersection: Church Road/State Route 38A
Direct connection or proximity to a stream?: Yes
Percent Vegetation & Type: 70% Grasses
Level of Erodibility: Moderate
Slope of Area: Moderate Grade
Length of Ditch: 500 ft
Management Recommended: Hydroseeding
Resolvability: Simple

Rank: High (Score = 40)
Estimated Cost: \$750

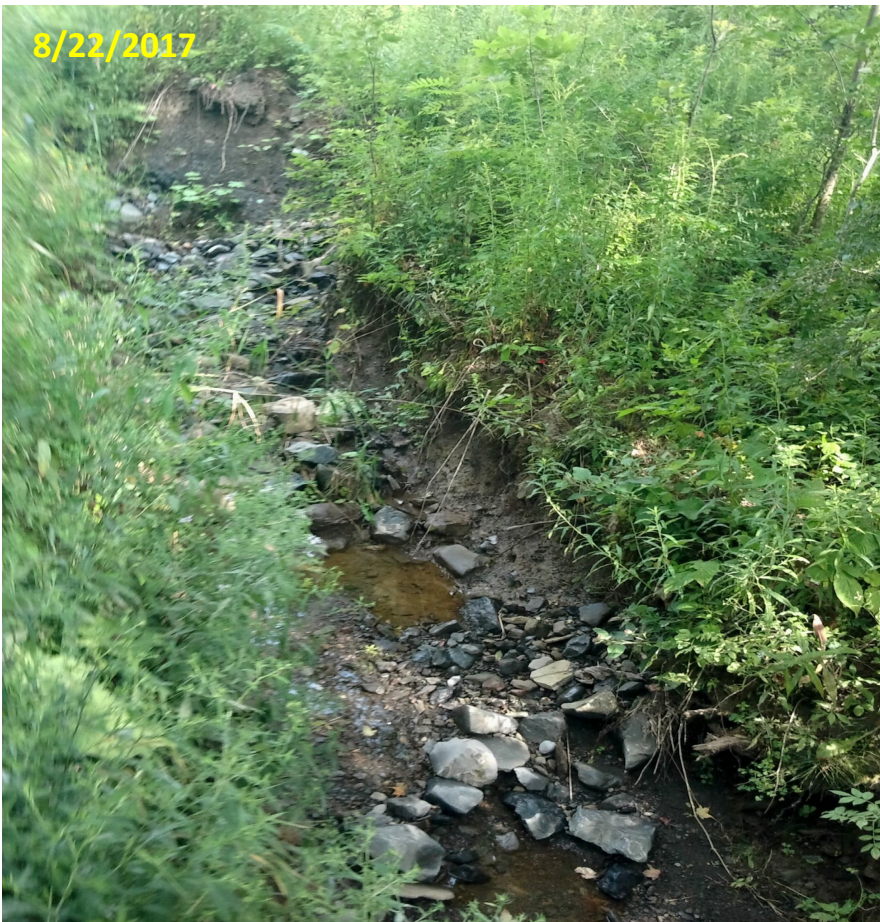
Map Identifier: Site 77
Sub-watershed: Decker Creek
Road Name: Church Road
Town: Moravia
Road Jurisdiction: Town of Moravia
Closest Intersection: Church Road/State Route 38A
Direct connection or proximity to a stream?: Yes
Percent Vegetation & Type: 50% Woody Shrubs
Level of Erodibility: High
Slope of Area: Moderate Grade
Length of Ditch: 200 ft
Management Recommended: Rock Armor
Resolvability: Difficult

Rank: High (Score = 40)
Estimated Cost: \$300

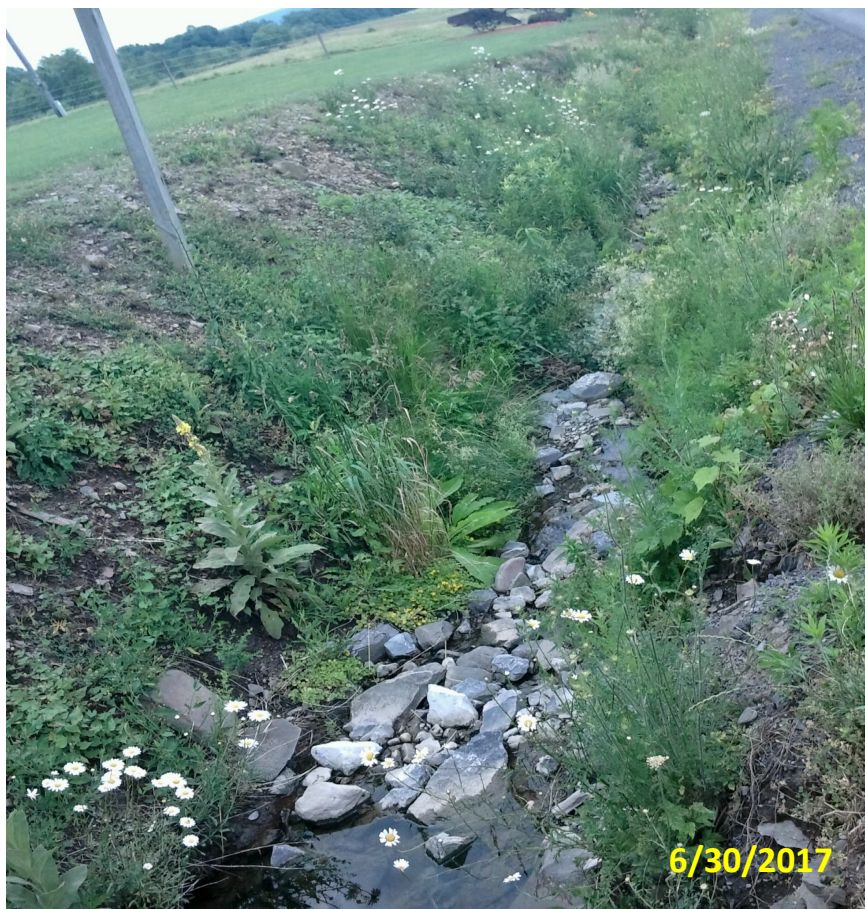
Map Identifier: Site 78
Sub-watershed: Decker Creek
Road Name: Jugg Street
Town: Moravia
Road Jurisdiction: Cayuga County Highway
Closest Intersection: Jugg Street/ Decker Hill Road
Direct connection or proximity to a stream?: Yes
Percent Vegetation & Type: 80% Grasses
Level or Erodibility: Low
Slope of Area: Moderate Grade
Length of Ditch: 150 ft
Management Recommended: Hydroseeding
Resolvability: Simple
Rank: Moderate (Score = 22)
Estimated Cost: \$225

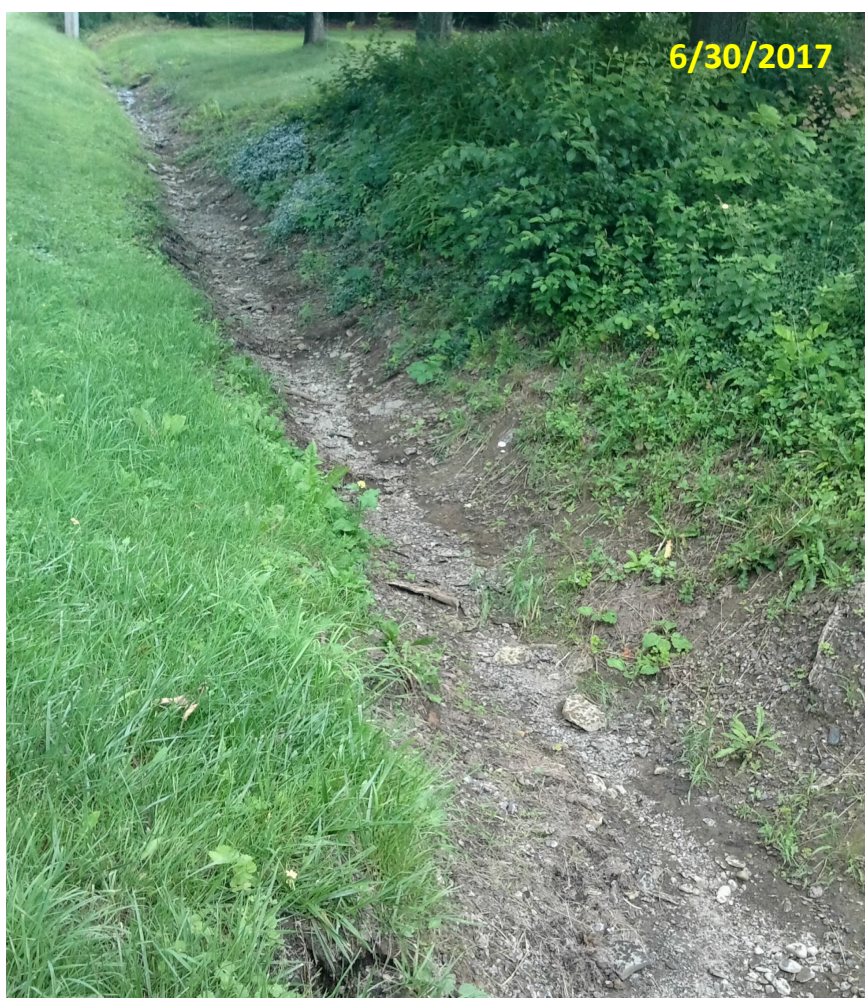
Map Identifier: Site 79
Sub-watershed: Decker Creek
Road Name: Jugg Street
Town: Moravia
Road Jurisdiction: Cayuga County Highway
Closest Intersection: Jugg Street/ Cheese Factory Road
Direct connection or proximity to a stream?: Yes
Percent Vegetation & Type: 30% Grasses
Level of Erodibility: Moderate
Slope of Area: Moderate Grade
Length of Ditch: 150 ft
Management Recommended: Hydroseeding
Resolvability: Moderate
Rank: Moderate (Score = 35)
Estimated Cost: \$225
Comments: Gravel at bottom of ditch
