## Improved Infrastructure Across the Owasco Lake Watershed

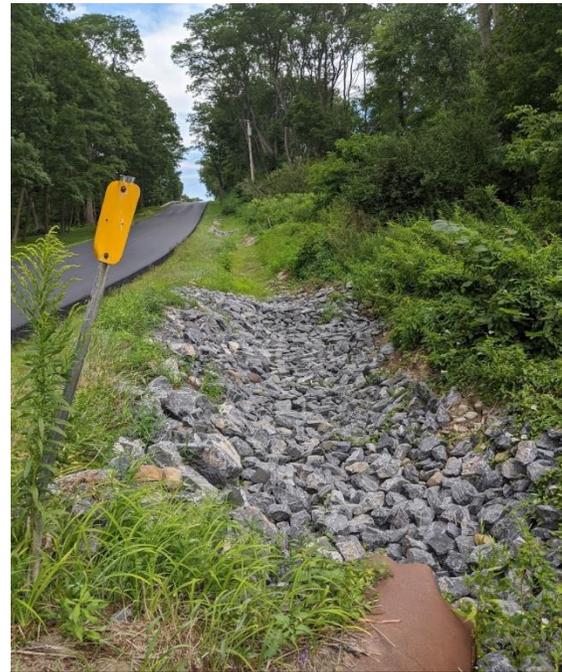
*Stone-line ditch, new hydroseeding, and culvert inlet stabilization on West Groton Road, Town of Lansing*

county roadways included stone armoring and velocity control dams, culvert aprons, as well as miles of hydroseeding along Pleasant

Valley, Town Line, Salt, and Locke Roads. According to their relatively small slice of the Owasco Inlet sub watershed, the Town of Dryden added stone velocity controls and hydroseeding in an unvegetated ditch along Hile School Road that drains into a wetland complex. The town of Groton spent thousands of dollars replacing a failing culvert on Walpole Road. An impressive concrete box structure was also replaced that included a comprehensive installation utilizing heavy stone armor, erosion control blankets, and new grass seeding along its sides to reduce erosion.
