Owasco Lake Watershed 2017 Roadside Ditch Assessment

The information included in this assessment was collected between late June and early July 2017. It reflects only a percentage of roadway ditches throughout the watershed that have been recently cleaned and have no visible management practices and/or have not been re-vegetated. The Inspection Program will continue to monitor these ditch segments for stabilization while others are being identified. Ditches that have been disturbed during 2017 and are experiencing erosion due to high water velocities and instability will also be scrutinized.

Road Ditch Assessment Sites in Niles (Cayuga County)

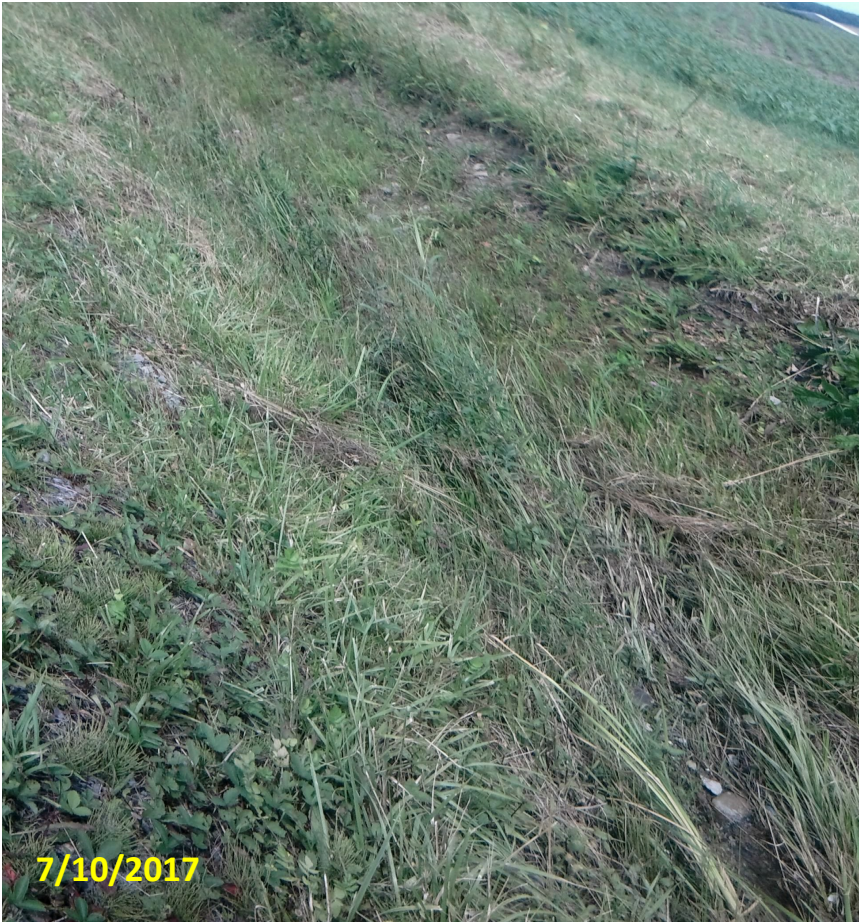
Map Identifier: Site 52
Sub-watershed: Dutch Hollow Brook
Road Name: Rowe Road
Town: Niles
Road Jurisdiction: Town of Niles
Closest Intersection: Rowe Road/ Twelve Corners Road
Direct connection or proximity to a stream?: Yes
Percent Vegetation & Type: 80% Grasses
Level of Erodibility: Low
Slope of Area: Moderate Grade
Length of Ditch: 1,450 ft
Management Recommended: Hydroseeding
Resolvability: Simple

Rank: Moderate (Score = 32)
Estimated Cost: \$2,175

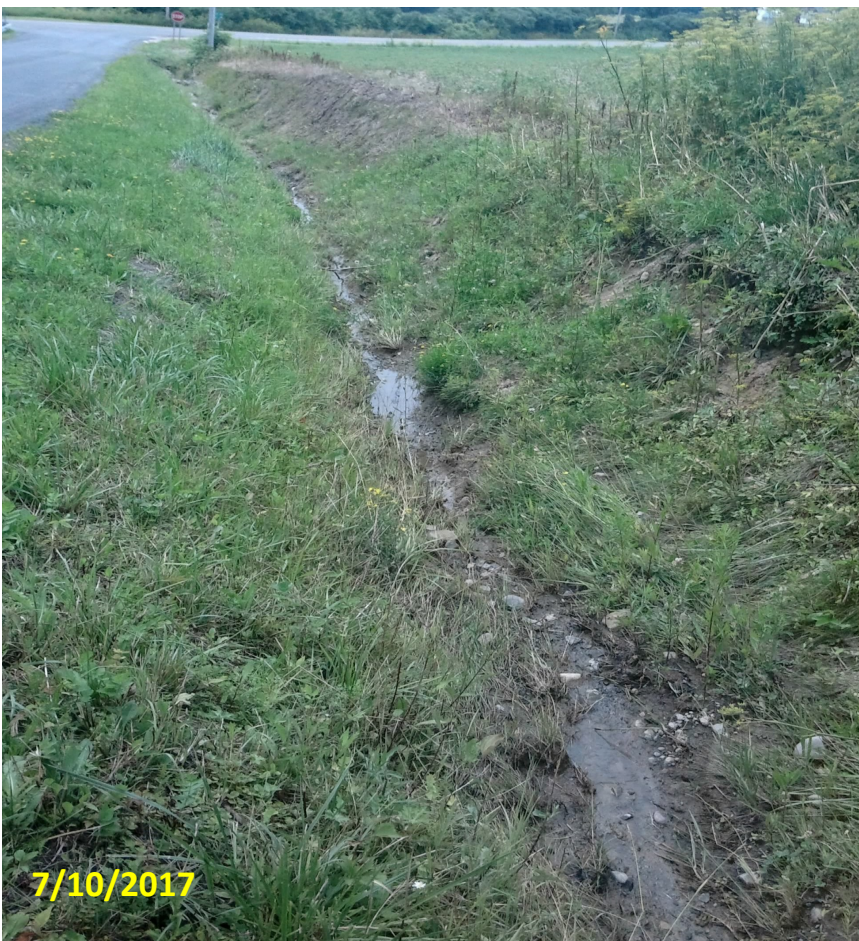
Map Identifier: Site 53
Sub-watershed: Dutch Hollow Brook
Road Name: Dewitt Road
Town: Niles
Road Jurisdiction: Town of Niles
Closest Intersection: Dewitt Road/ State Route 38A
Direct connection or proximity to a stream?: No
Percent Vegetation & Type: 50% Grasses
Level of Erodibility: Moderate
Slope of Area: Moderate Grade
Length of Ditch: 550 ft
Management Recommended: Hydroseeding
Resolvability: Moderate

Rank: Moderate (Score = 35)
Estimated Cost: \$825

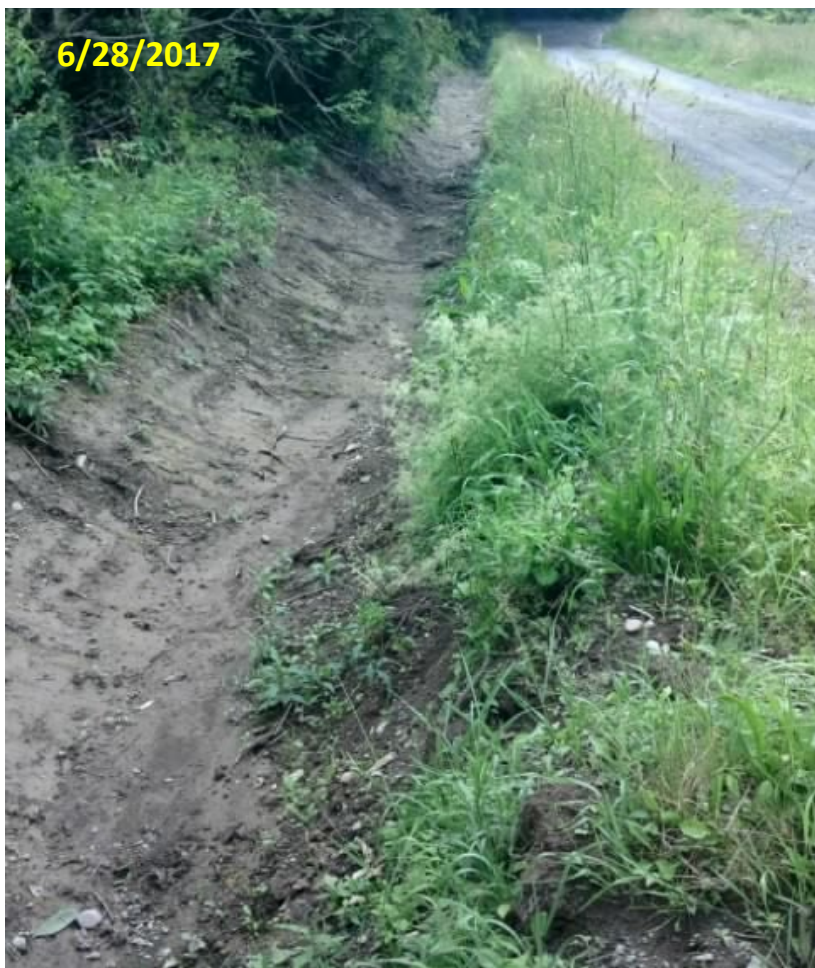
Map Identifier: Site 54
Sub-watershed: Dutch Hollow Brook
Road Name: Richardson Road
Town: Niles
Road Jurisdiction: Town of Niles
Closest Intersection: Richardson Road/
 Murray Road
Direct connection or proximity to a stream?: No
Percent Vegetation & Type: 50%
 Grasses
Level of Erodibility: Moderate
Slope of Area: Moderate Grade
Length of Ditch: 800 ft
Management Recommended:
 Hydroseeding
Resolvability: Simple

Rank: Moderate (Score = 35)
Estimated Cost: \$1,200
Comments: Erosion on both sides of road, split into several segments

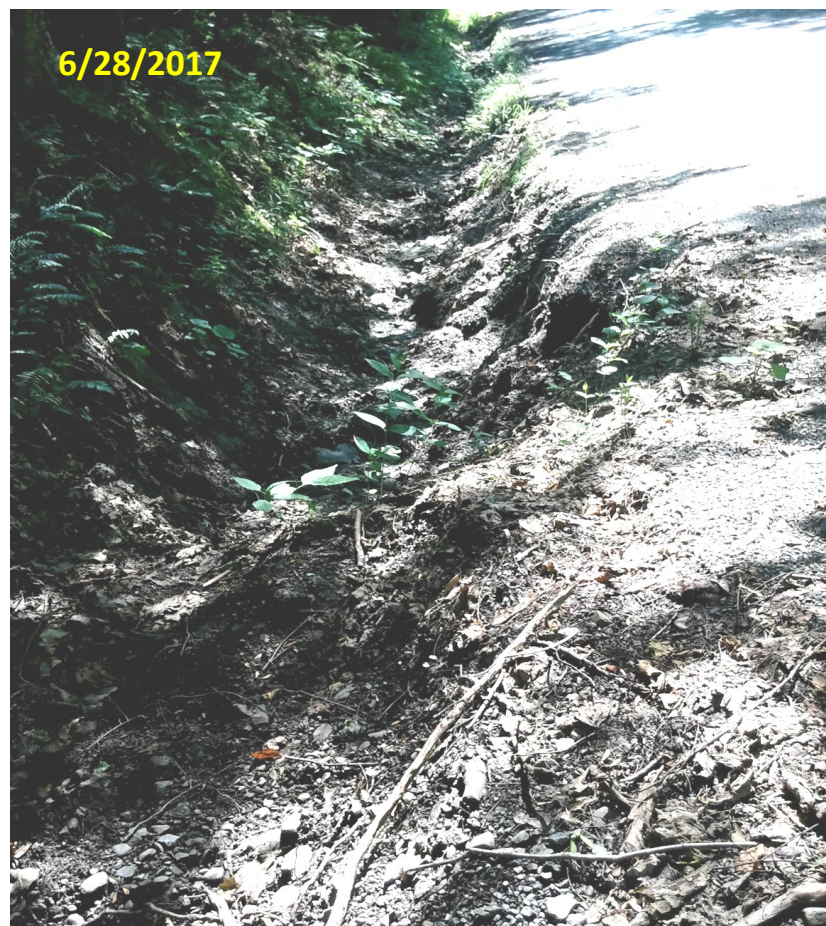
Map Identifier: Site 55
Sub-watershed: Dutch Hollow Brook
Road Name: Murray Road
Town: Niles
Road Jurisdiction: Town of Niles
Closest Intersection: Murray Road/
 Richardson Road
Direct connection or proximity to a stream?: Yes
Percent Vegetation & Type: 50%
 Mature Trees
Level of Erodibility: Moderate
Slope of Area: Steep Grade
Length of Ditch: 1,600 ft
Management Recommended:
 Hydroseeding
Resolvability: Moderate

Rank: High (Score = 50)
Estimated Cost: \$2,400
Comments: Located in forested area

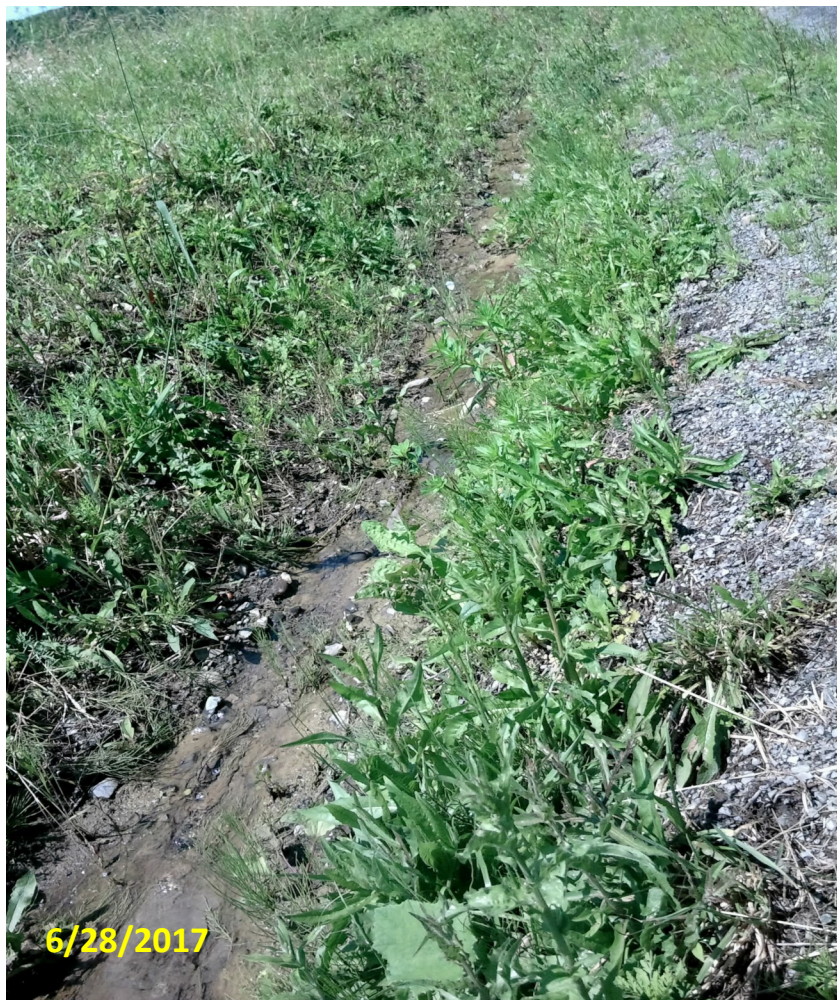
Map Identifier: Site 56
Sub-watershed: Dutch Hollow Brook
Road Name: Murray Road
Town: Niles
Road Jurisdiction: Town of Niles
Closest Intersection: Murray Road/
 Twelve Corners Road
Direct connection or proximity to a stream?: Yes
Percent Vegetation & Type: 80%
 Grasses
Level of Erodibility: Low
Slope of Area: Moderate Grade
Length of Ditch: 950 ft
Management Recommended:
 Hydroseeding
Resolvability: Simple

Rank: Moderate (Score = 32)
Estimated Cost: \$1,425
Comments: Gravel in some areas of
 ditch, erosion on both sides of road

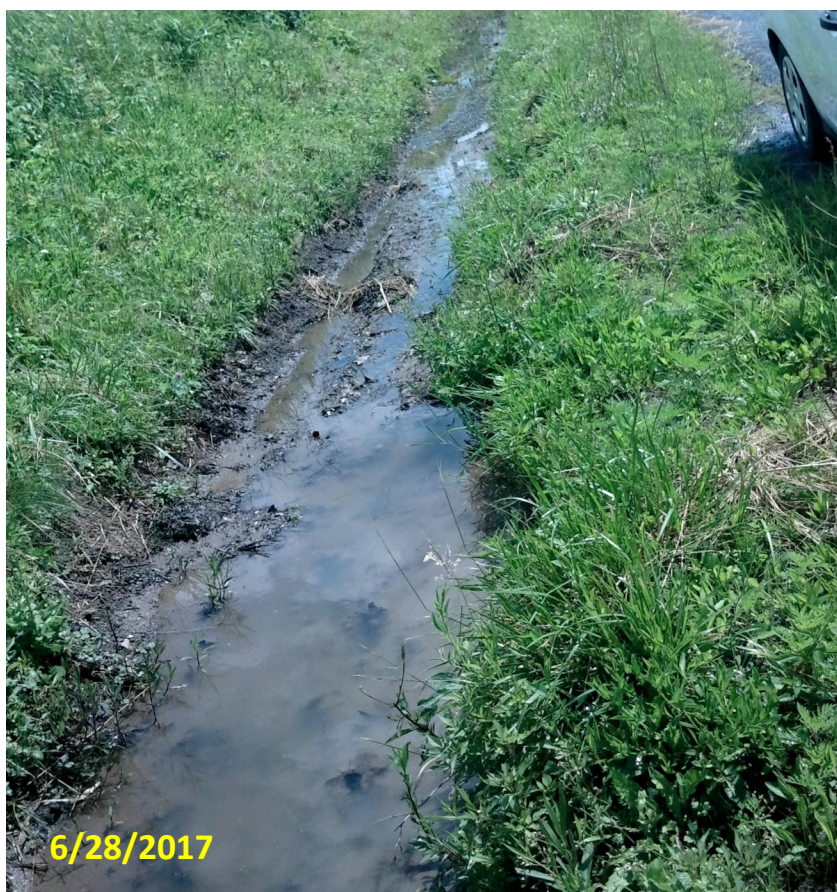
Map Identifier: Site 57
Sub-watershed: Dutch Hollow Brook
Road Name: Murray Road
Town: Niles
Road Jurisdiction: Town of Niles
Closest Intersection: Murray Road/
 Twelve Corners Road
Direct connection or proximity to a stream?: Yes
Percent Vegetation & Type: 75%
 Grasses
Level of Erodibility: Moderate
Slope of Area: Moderate Grade
Length of Ditch: 550 ft
Management Recommended:
 Hydroseeding
Resolvability: Moderate

Rank: High (Score = 40)
Estimated Cost: \$825

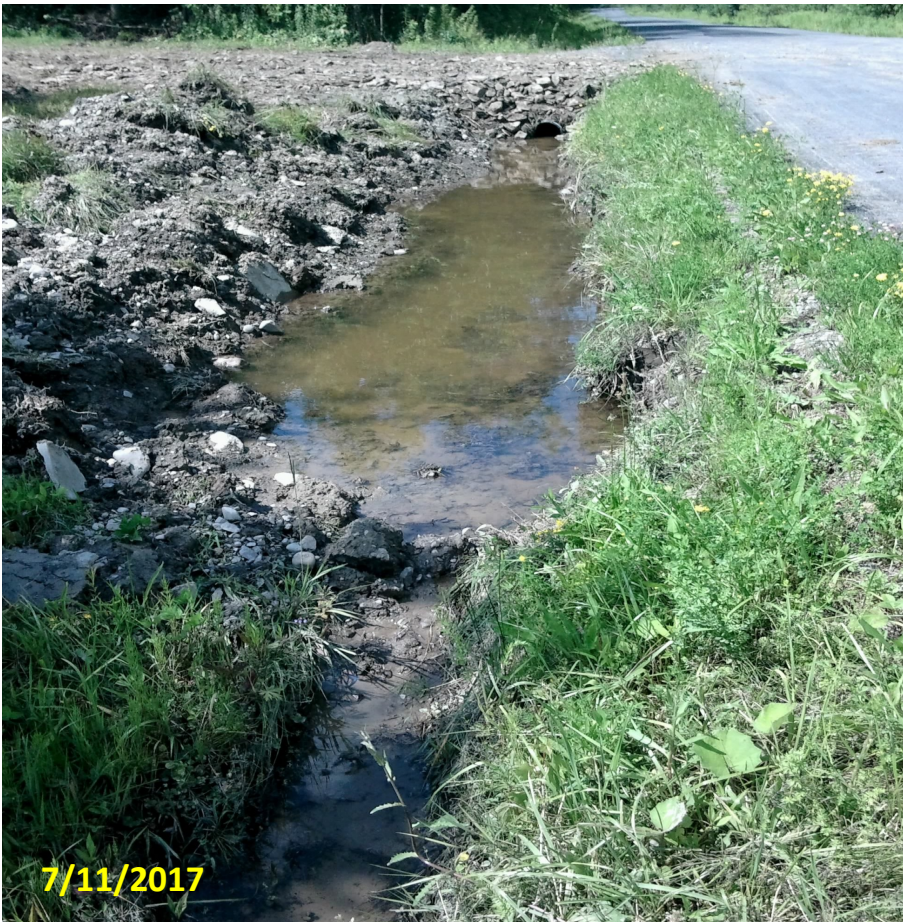
Map Identifier: Site 58
Sub-watershed: Decker Creek
Road Name: Corrigan Road
Town: Niles
Road Jurisdiction: Town of Niles
Closest Intersection: Corrigan Road/Church Road
Direct connection or proximity to a stream?: No
Percent Vegetation & Type: 25% Grasses
Level of Erodibility: High
Slope of Area: Flat
Length of Ditch: 50 ft
Management Recommended: Rock Armor
Resolvability: Difficult

Rank: Moderate (Score = 31)
Estimated Cost: \$75

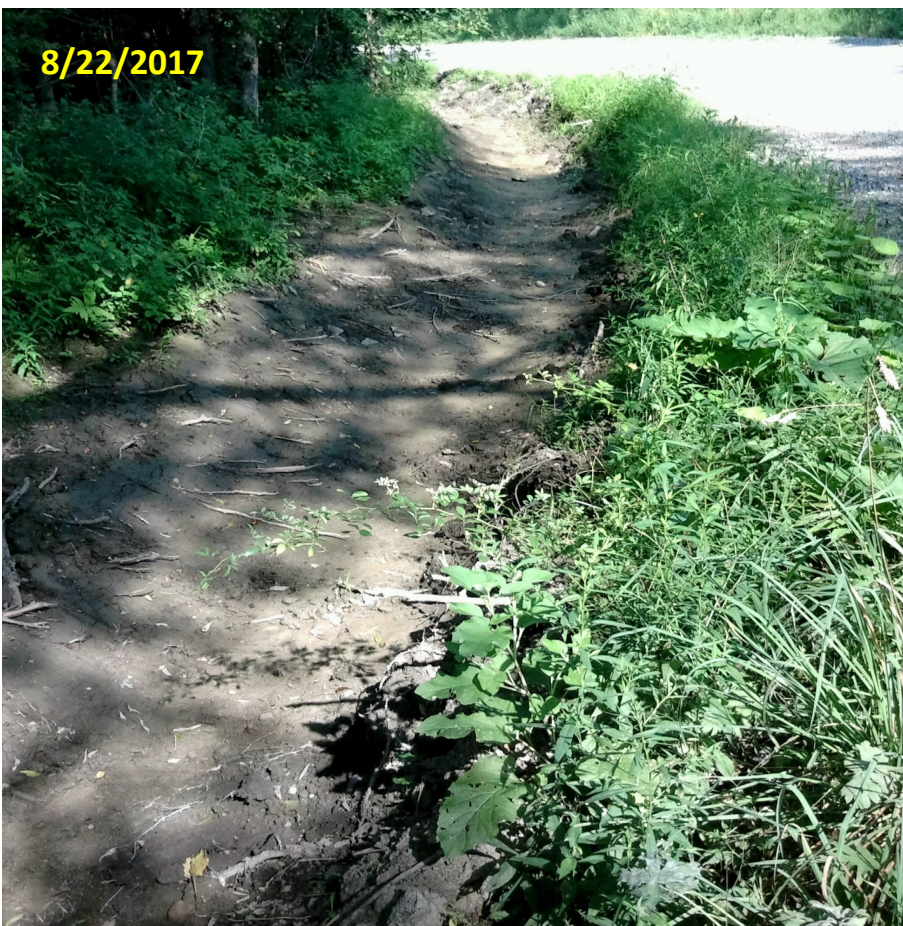
Map Identifier: Site 59
Sub-watershed: Decker Creek
Road Name: Church Road
Town: Niles
Road Jurisdiction: Town of Niles
Closest Intersection: Church Road/State Route 38A
Direct connection or proximity to a stream?: Yes
Percent Vegetation & Type: 15% Grasses
Level of Erodibility: High
Slope of Area: Moderate Grade
Length of Ditch: 650 ft
Management Recommended: Hydroseeding
Resolvability: Moderate

Rank: High (Score = 55)
Estimated Cost: \$975

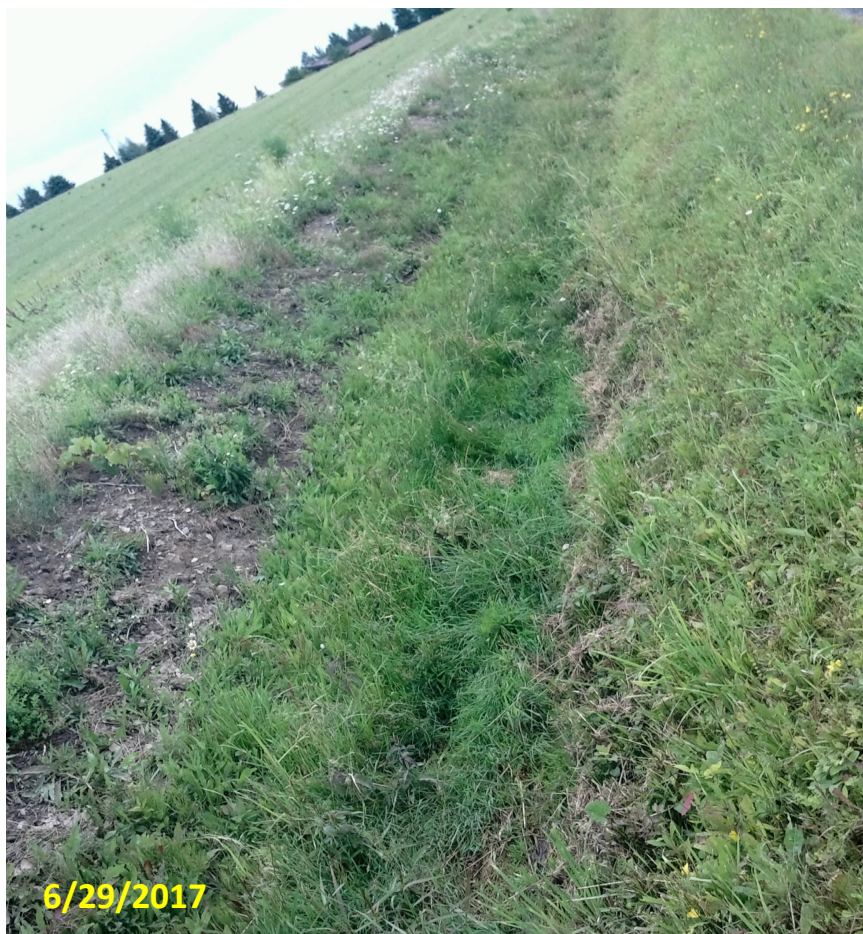
Map Identifier: Site 60
Sub-watershed: Dutch Hollow Brook
Road Name: Split Rock Road
Town: Niles
Road Jurisdiction: Town of Niles
Closest Intersection: Split Rock Road/Old Salt Road
Direct connection or proximity to a stream?: Yes
Percent Vegetation & Type: 80% Grasses
Level of Erodibility: Low
Slope of Area: Moderate Grade
Length of Ditch: 1,100 ft
Management Recommended: Hydroseeding
Resolvability: Simple

Rank: Moderate (Rank = 32)
Estimated Cost: \$1,650

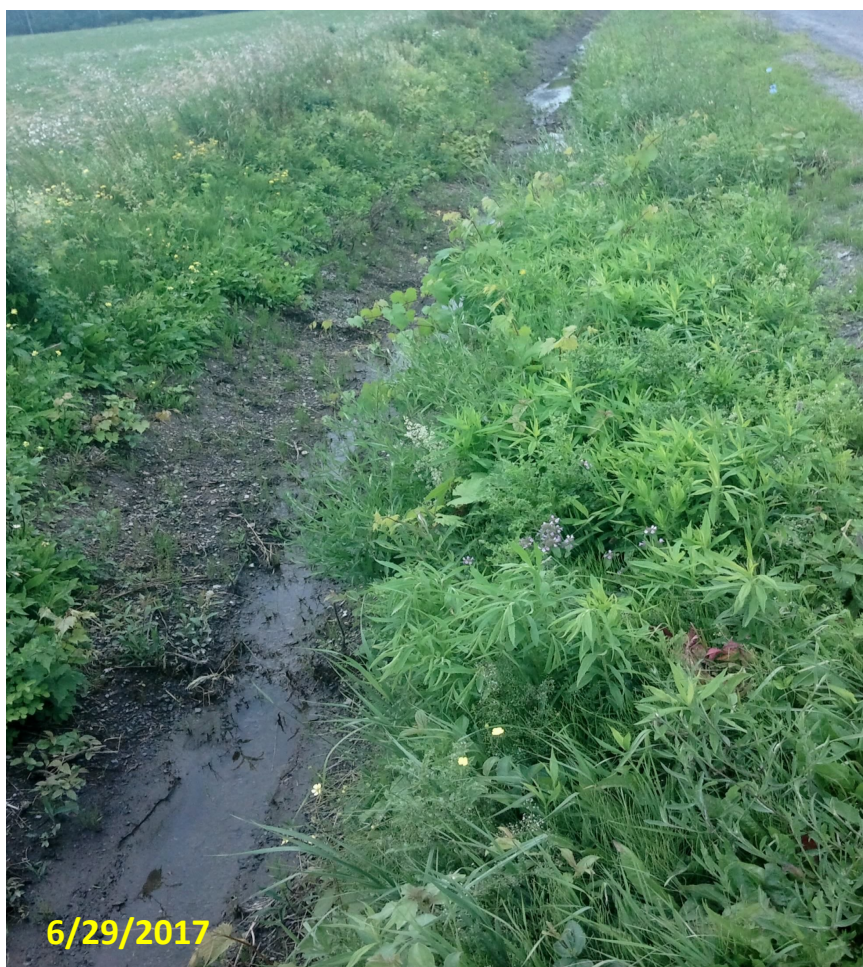
Map Identifier: Site 61
Sub-watershed: Dutch Hollow Brook
Road Name: Old Salt Road
Town: Niles
Road Jurisdiction: Cayuga County Highway
Closest Intersection: Old Salt Road/Cream Hollow Road
Direct connection or proximity to a stream?: Yes
Percent Vegetation & Type: 50% Grasses
Level of Erodibility: Moderate
Slope of Area: Moderate Grade
Length of Ditch: 800 ft
Management Recommended: Hydroseeding
Resolvability: Simple

Rank: High (Score = 45)
Estimated Cost: \$1,200

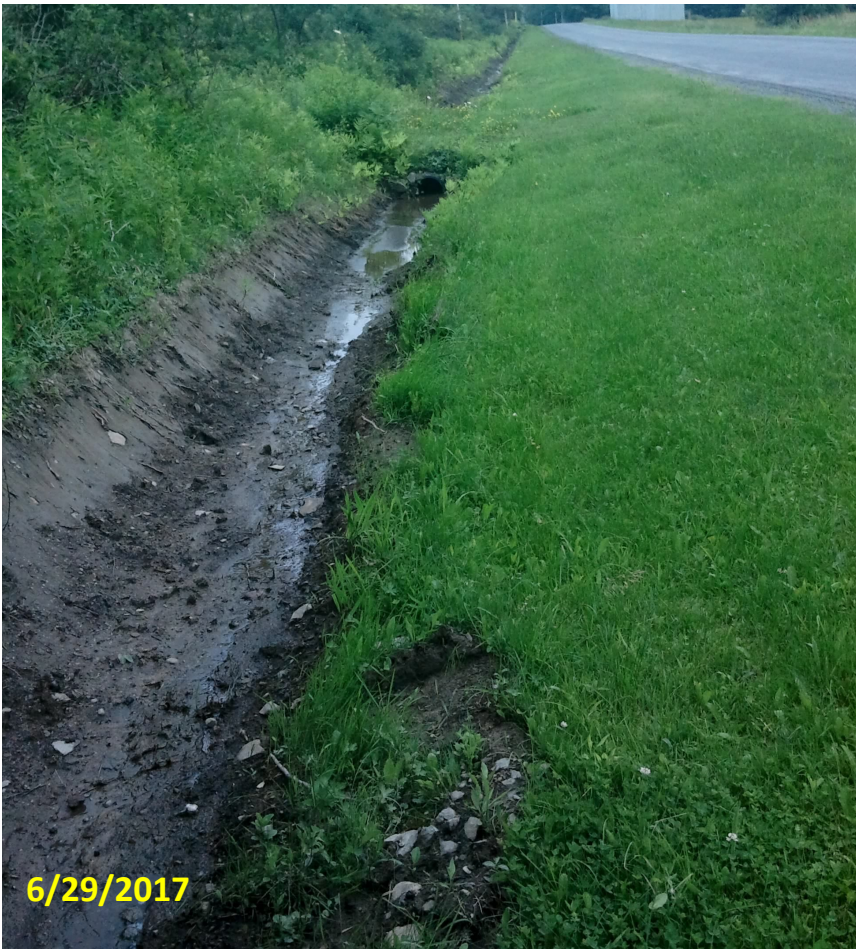
Map Identifier: Site 62
Sub-watershed: Dutch Hollow Brook
Road Name: Old Salt Road
Town: Niles
Road Jurisdiction: Cayuga County Highway
Closest Intersection: Old Salt Road/ Burdock Road
Direct connection or proximity to a stream?: Yes
Percent Vegetation & Type: 5% Grasses
Level of Erodibility: Moderate
Slope of Area: Moderate Grade
Length of Ditch: 800 ft
Management Recommended: Hydroseeding
Resolvability: Simple

Rank: High (Score = 50)
Estimated Cost: \$1,200

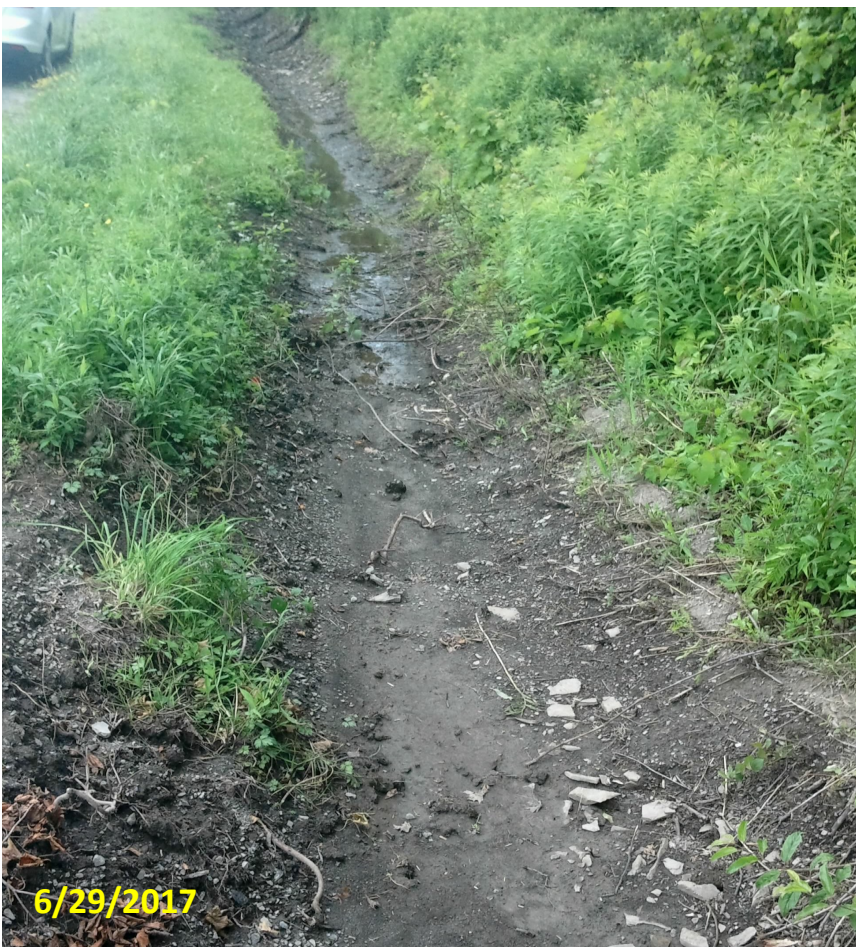
Map Identifier: Site 63
Sub-watershed: Dutch Hollow Brook
Road Name: Old Salt Road
Town: Niles
Road Jurisdiction: Cayuga County Highway
Closest Intersection: Old Salt Road/ Globe Road
Direct connection or proximity to a stream?: Yes
Percent Vegetation & Type: 5% Grasses
Level of Erodibility: Moderate
Slope of Area: Moderate Grade
Length of Ditch: 1,700 ft
Management Recommended: Hydroseeding
Resolvability: Simple

Rank: High (Score = 50)
Estimated Cost: \$2,550

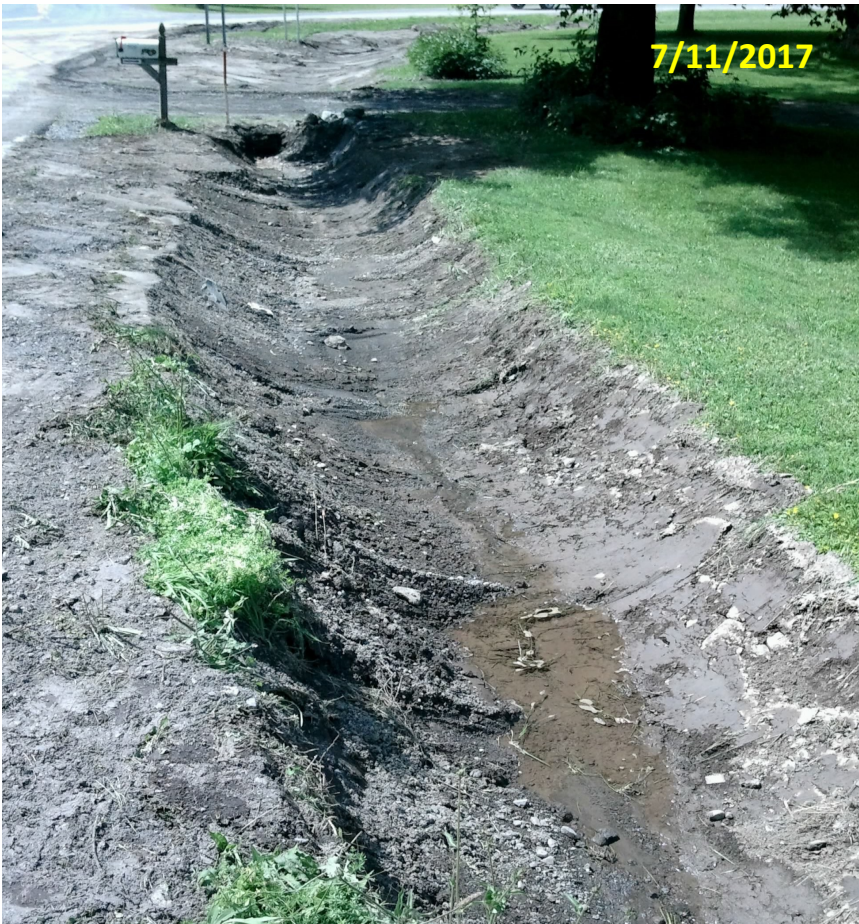
Map Identifier: Site 64
Sub-watershed: Decker Creek
Road Name: Globe Road
Town: Niles
Road Jurisdiction: Cayuga County Highway
Closest Intersection: Globe Road/ Route 38A
Direct connection or proximity to a stream?: No
Percent Vegetation & Type: 0%
Level of Erodibility: Moderate
Slope of Area: Moderate Grade
Length of Ditch: 100 ft
Management Recommended: Hydroseeding
Resolvability: Simple

Rank: Moderate (Score = 30)
Estimated Cost: \$150
Comments: Recently cleared

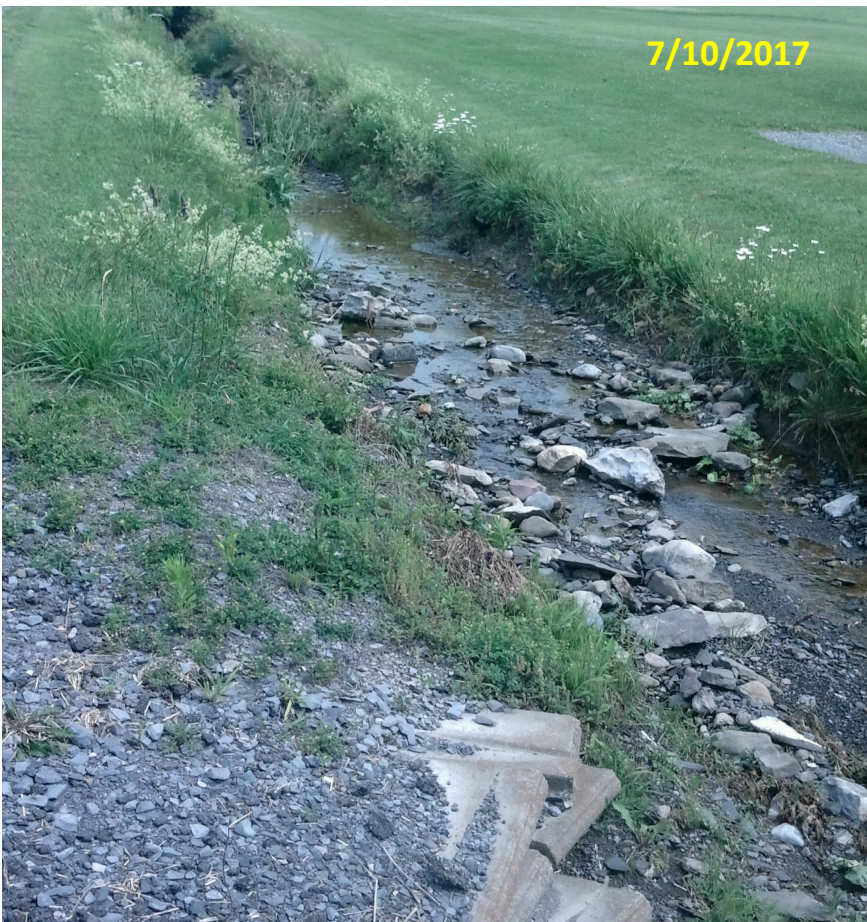
Map Identifier: Site 65
Sub-watershed: Decker Creek
Road Name: Globe Road
Town: Niles
Road Jurisdiction: Cayuga County Highway
Closest Intersection: Globe Road/ Route 38A
Direct connection or proximity to a stream?: No
Percent Vegetation & Type: 50% Grasses
Level of Erodibility: Moderate
Slope of Area: Moderate Grade
Length of Ditch: 150 ft
Management Recommended: Hydroseeding
Resolvability: Moderate

Rank: Moderate (Score = 25)
Estimated Cost: \$225
