Owasco Lake Watershed Inspection Program

2015 Annual Report

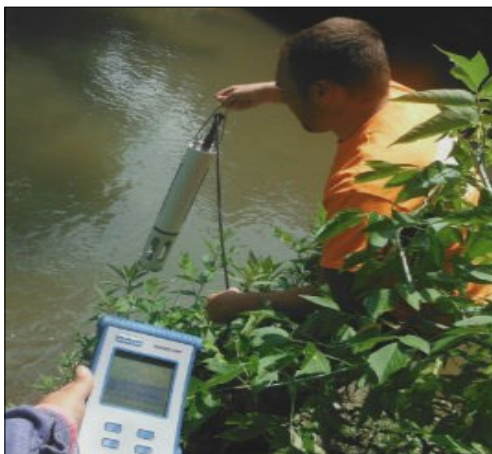
Inspectors use the Hydrolab to test water quality parameters like pH, temperature, and nutrient levels.

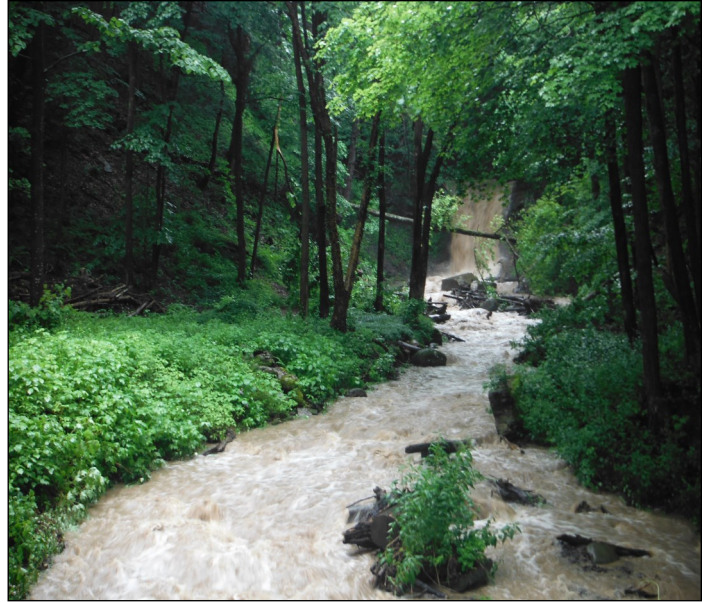
Heavy June rains caused severe erosion and turbidity in streams throughout the watershed (above). Widespread sediment plumes resulted along lake shorelines as sediment-laden flows emptied into the lake from the major tributaries (bottom right).

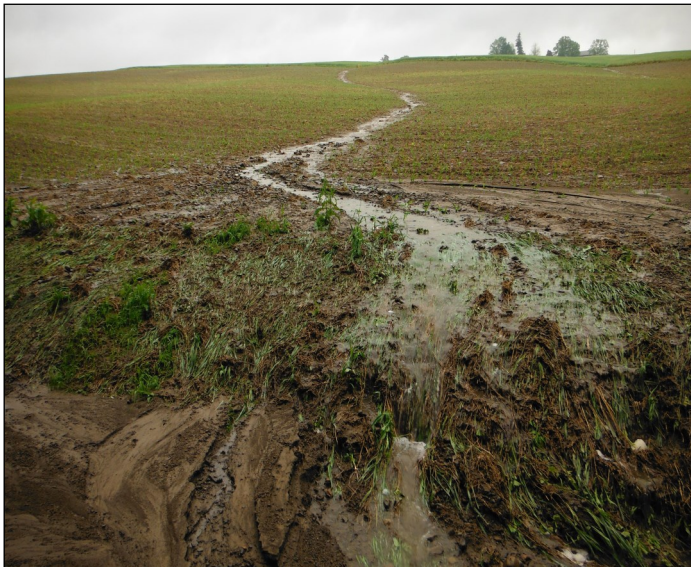
Steep slopes, similar to this field near Rockefeller Road, were subject to erosion and substantial soil losses during rain events in 2015 (see pgs. 6, 7).

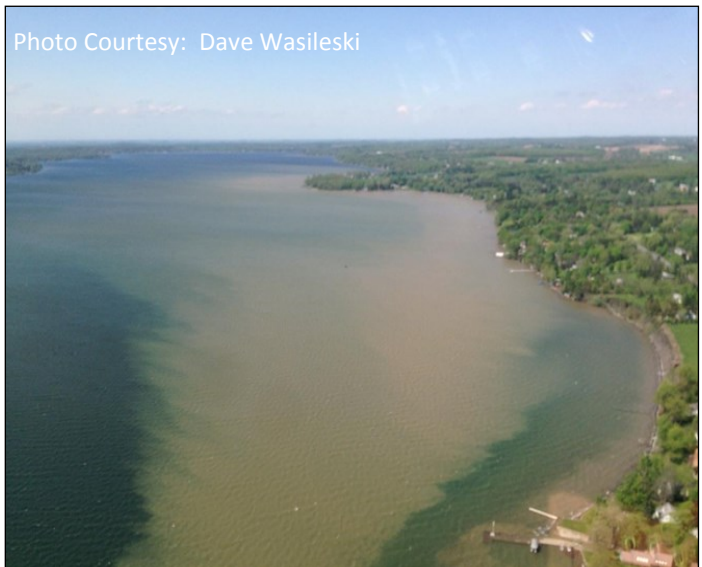
A massive sediment plume along the eastern shore of Owasco Lake, looking north to Burtis Point. Plumes were frequently observed around the lake after heavy June rainfall events.

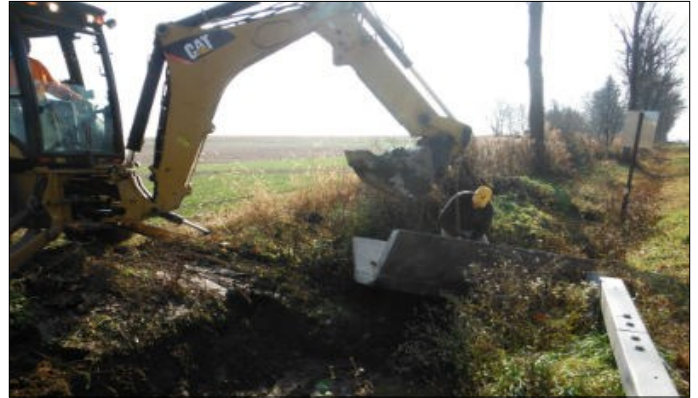
Owasco Highway Department personnel help install the first pilot sediment trap on Town Hall Road.

With funds provided by the Emerson Foundation, the Inspection Program and the Cayuga County Soil and Water Conservation District (SWCD) staff constructed a set of concrete sediment traps during the winter months of 2014 (photos right).

The concrete traps are designed to capture soil particles to reduce nutrient loading in streams and Owasco Lake, and allow for simple cleanout by road crews. These new traps are the "pilot" structures to demonstrate the effectiveness of capturing sediments being transported through ditches with stormwater. Inspection staff will continuously monitor the traps for deposition quantities throughout the year.

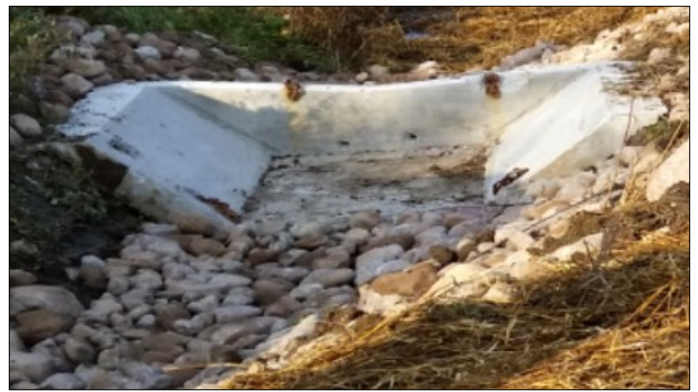
Completed installation of the first pilot sediment trap on Town Hall Road (November 2015).

One of two sediment traps was recently placed on Town Hall Road in Owasco, to intercept and contain sediments before they enter Sucker Brook (right). The second sediment trap is slated to be placed on Martin Road in Owasco, adjacent to Dutch Hollow Brook.

The sediment traps are a simple, durable method to consider for ditch stabilization, especially on steep slopes. The Inspection Program encourages the use of the sediment traps and by regularly monitoring the amount of sediment they retain, will evaluate the positive impact the traps can have on water quality.

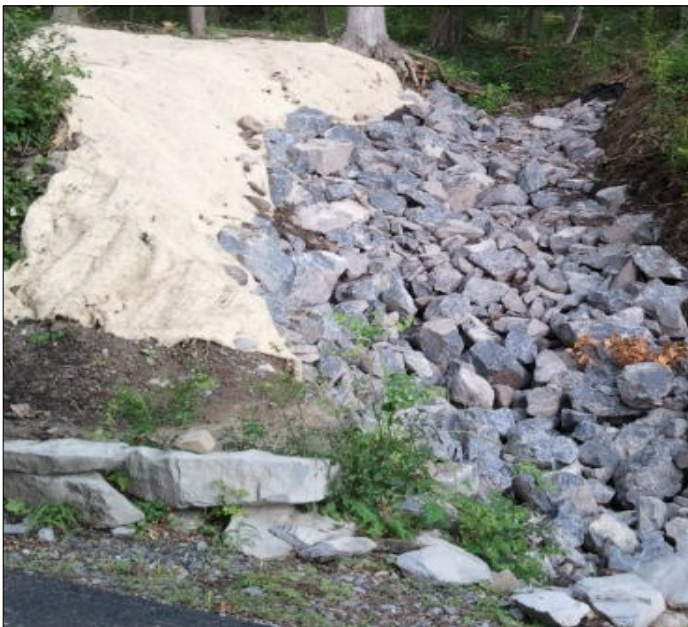
This site on East Lake Road in Owasco demonstrates the use of a variety of erosion and sediment control methods on a severely eroding site. The methods shown in the photo include: a burlap-like rolled erosion product (left), and angular stone protection or "riprap" (right).

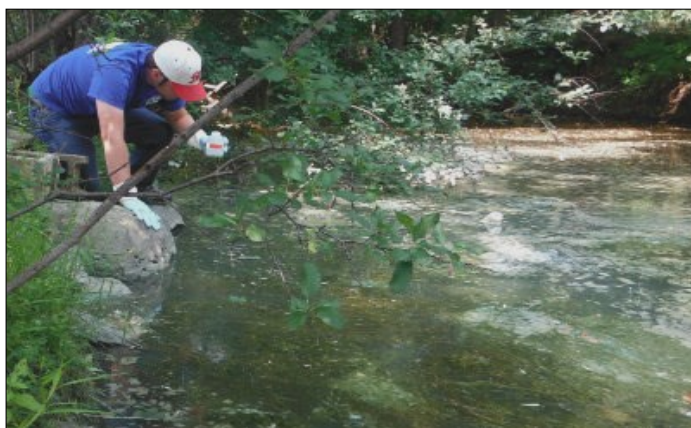
Tim Schneider takes a Harmful Algal Bloom (HAB) sample near the mouth of Sucker Brook as a part of the 2015 algae monitoring effort (see pg. 9 for program details and results).

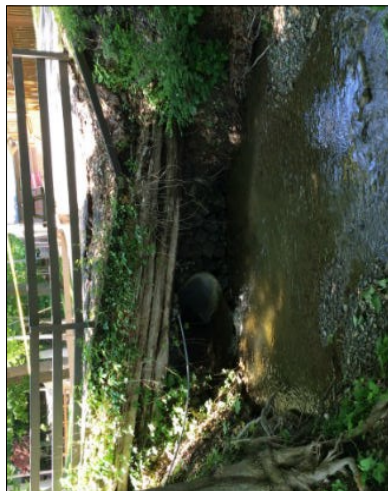
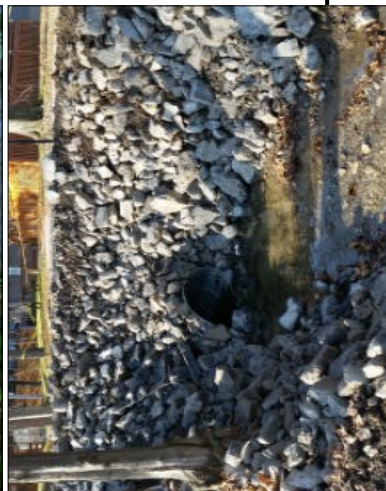
Inspection Program staff assisted with a culvert replacement project at Camp Casowasco. The project involved stabilization of the streambank as well as the culvert walls. The culvert replacement also created a more natural passageway for aquatic organisms, including spring smelt.

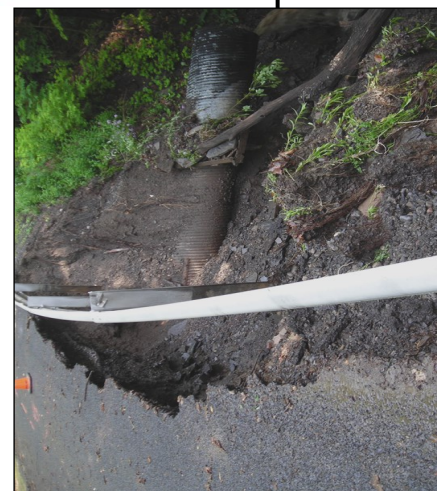
In the last few years, strong, localized rainstorms have become more frequent. As a result, many small streams around the watershed are experiencing severe bank erosion. The site pictured here demonstrates the scouring that is typical of bank erosion. The Inspection Program works with landowners throughout the watershed to plan and implement practices that will increase the resiliency of highly erodible streambanks.

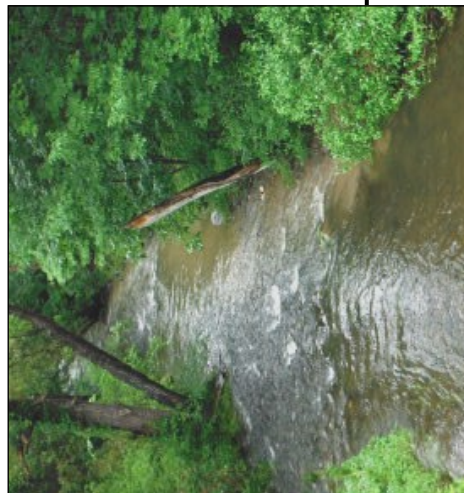
Heavy rains during 2015 caused severe soil erosion throughout the watershed. The photos of Hemlock Creek (above) demonstrate how turbid (sediment-laden) water flowing into ditches can impact water clarity in streams. The Inspection Program monitors streams to determine the origins of turbid water in an effort to reduce the movement of soil and nutrient particles into streams and Owasco Lake.

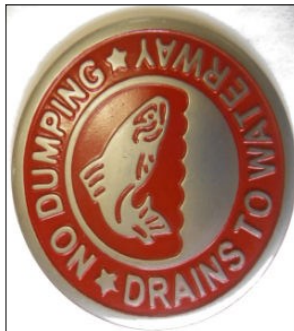
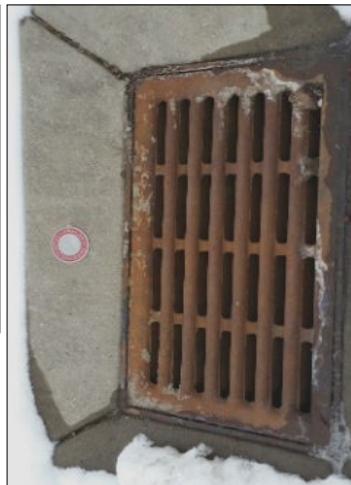
Medallions were placed on stormwater drains around the Village of Moravia and Town of Owasco. These medallions serve as a reminder to avoid disposing of waste into drains, and to keep them clear of debris at all times. Clean, clear stormwater drains will help protect the water quality in Owasco Lake.

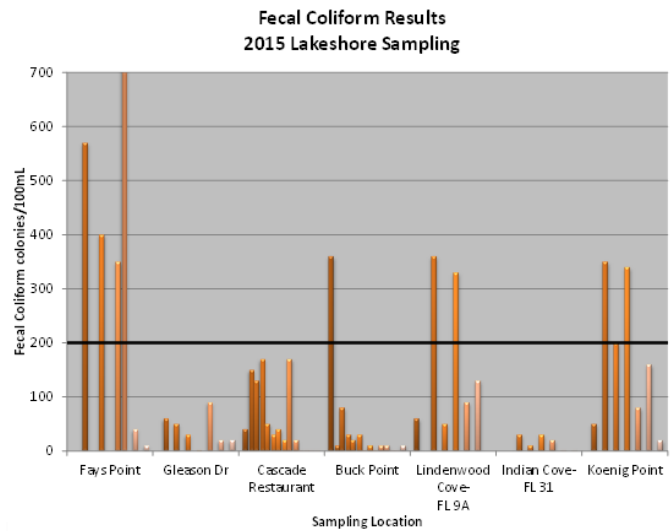
The graphs on this page summarize the 2015 fecal coliform water sampling results from 7 lakeshore and 6 tributary locations (right). Each vertical bar represents weekly bacteria results at the corresponding sampling location.

Results of less than **200** fecal coliform per 100 milliliters (mL) (**bold line**) generally indicate a bacterial level considered 'good' and suitable for bathing. 'Spikes' or high bacteria levels on the graphs were typical after heavy precipitation events during the summer of 2015. Visit www.owascoinspection.org for more information.

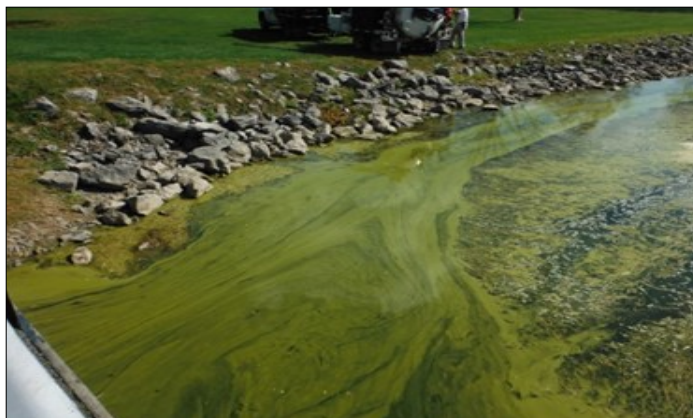
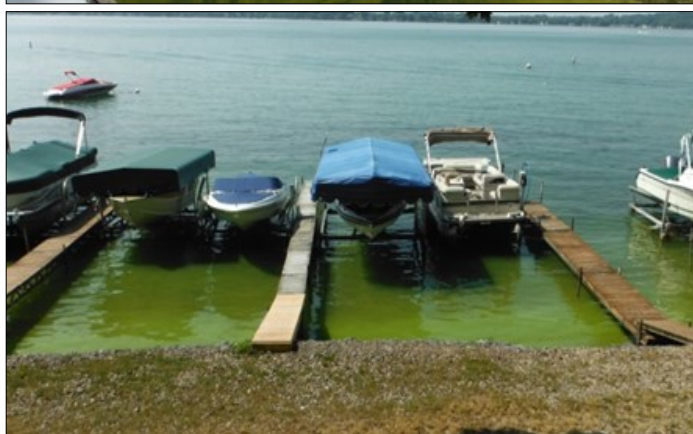
2015 Cyanobacteria and Nutrient Sample Results

Date	Location	Cyanobacteria Concentration	Toxin Concentration
7/9	Peterson Point	31 ug/L*	<2.87 ug/L
7/13	Mouth of Sucker Brook	785 ug/L*	<2.61 ug/L
7/27	Near Bouy off Burtis Point	<13 ug/L	<1.35 ug/L
7/29	Northeast Shore near Emerson Park	<13 ug/L	<1.35 ug/L
8/19	Near Buoy off Burtis Pt.	<13 ug/L	<1.35 ug/L
8/19	Near Buoy off Burtis Pt.	<13 ug/L	<1.35 ug/L
9/2	Yacht Club	954 ug/L*	330 ug/L**
9/2	Martin Point	68 ug/L *	9 ug/L
9/2	Firelane 23E	73 ug/L*	10 ug/L
9/3	Lindewood Cove	252 ug/L*	62 ug/L**
9/3	Yacht Club	4515 ug/L*	558 ug/L**
9/4	Mouth of Sucker Brook	185 ug/L*	36 ug/L **
9/4	Holland Drive	2356 ug/L*	530 ug/L**
9/16	Firelane 3W	679 ug/L*	243 ug/L**
9/17	Mouth of Dutch Hollow	140 ug/L*	104 ug/L**
9/17	Mouth of Sucker Brook	83 ug/L*	39 ug/L**
9/17	Indian Cove	886 ug/L*	792 ug/L**
9/17	Firelane 23E	246 ug/L*	161 ug/L**
9/25	Firelane 3W	139 ug/L*	105 ug/L**
10/4	Firelane 3W	3478 ug/L*	808 ug/L **
10/5	Mouth of Veness Brook	96 ug/L*	202 ug/L **

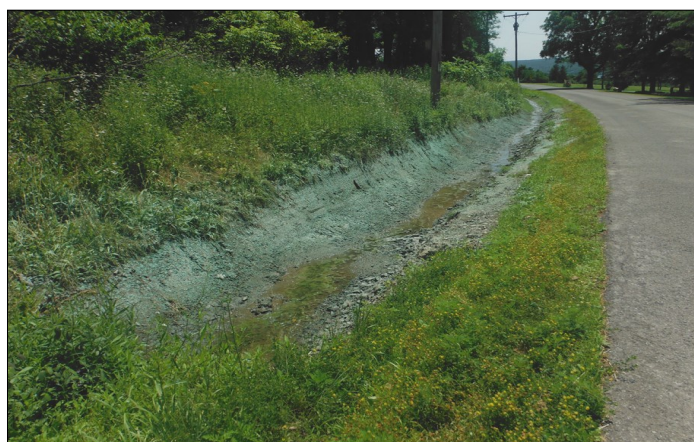
Hydroseeding is an effective and inexpensive practice for stabilizing roadside ditches to minimize erosion and prevent nutrient loading in waterways.

The goals of this project are to stabilize nearly 100 miles of road ditches over the next 5 years, purchase supplies and materials for implementation, and **substantially reduce the amount of sediment** flowing through the ditch networks into tributaries and Owasco Lake.

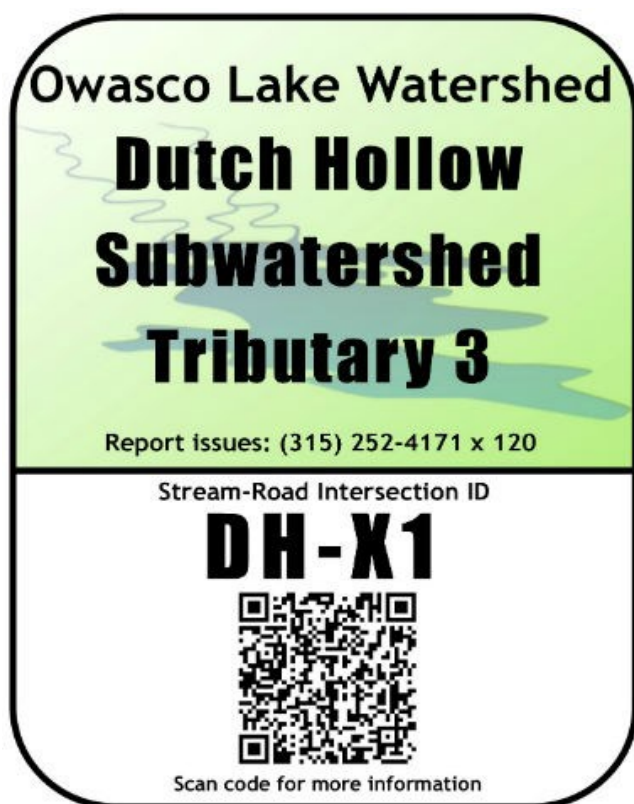
The current design-in-progress for signs that will identify stream-road crossings throughout the watershed. Signs will provide a unique code with which a crossing can be easily identified, contact phone numbers, and a smartphone link to educational information about each tributary.

The signage will include the name of the sub watershed/tributary flowing at a specific road crossing, as well as "quick response" (QR) scan codes that will link smartphone users to a database with specific biological, physical, and geographical information about each tributary. Emergency contact information will also be included for the public to report noticeable water quality issues at the location.

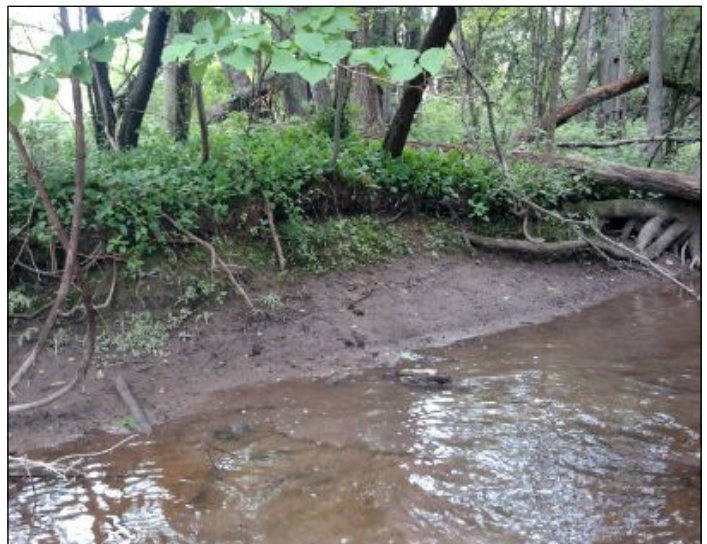
The bank shown is one of many experiencing severe erosion on Sucker Brook. High velocity water has scoured soil and left tree roots exposed, a process known as undermining. Bank stabilization measures will minimize erosion by reducing the amount of bare soil exposed to high velocity water.
