OWASCO LAKE WATERSHED INSPECTION PROGRAM (OLWIP)

2014 ANNUAL REPORT

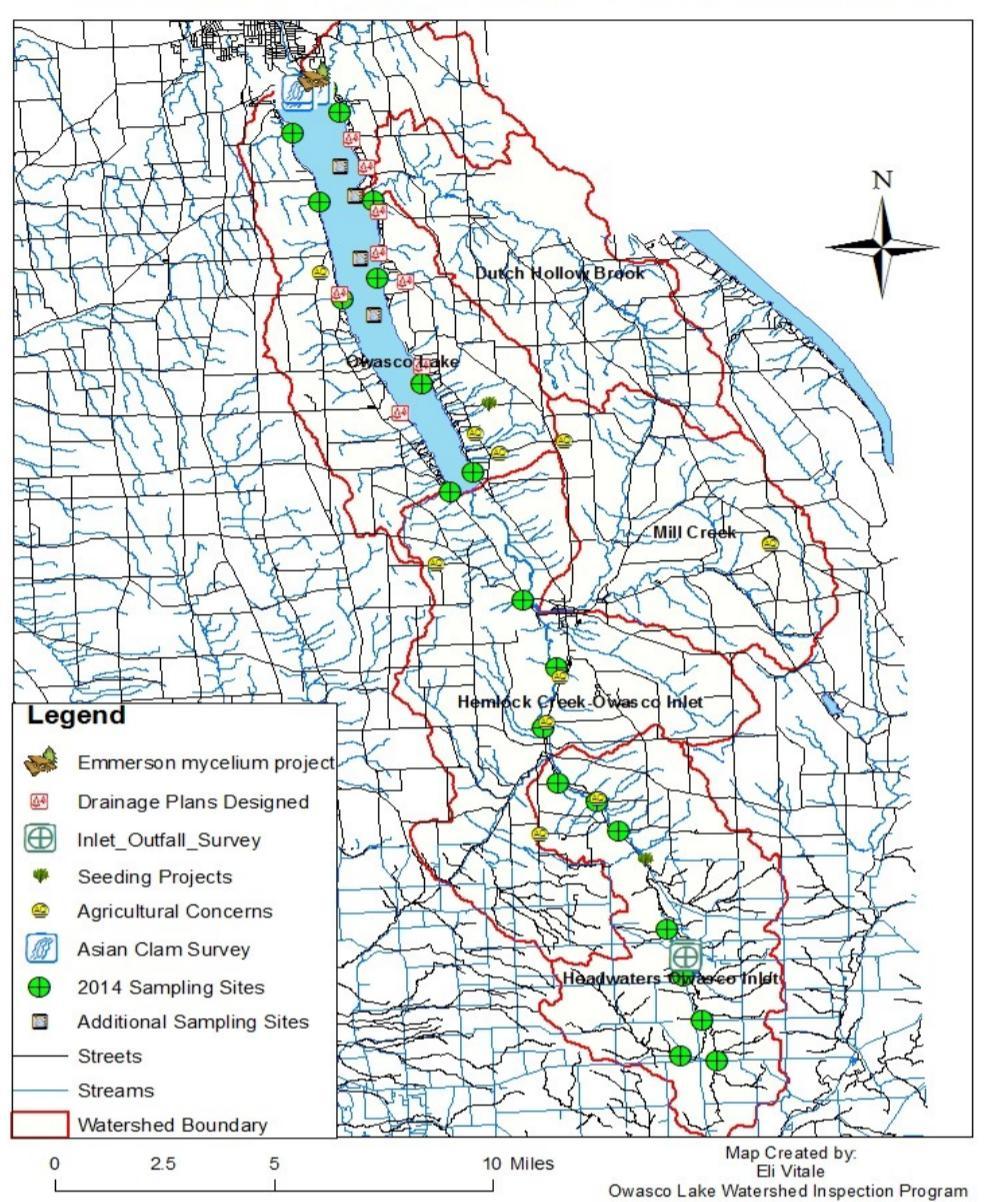
Owasco Lake Watershed 2014 Areas of Concern

The abnormally wet year allowed the Inspection Program to identify and document a significant number of areas (map to the right). These areas included drainage problems in residential areas, land & shoreline construction, nutrient applications (ag/non-ag), septic issues, and most prevalent during 2014 - tributary streambank/soil erosion!

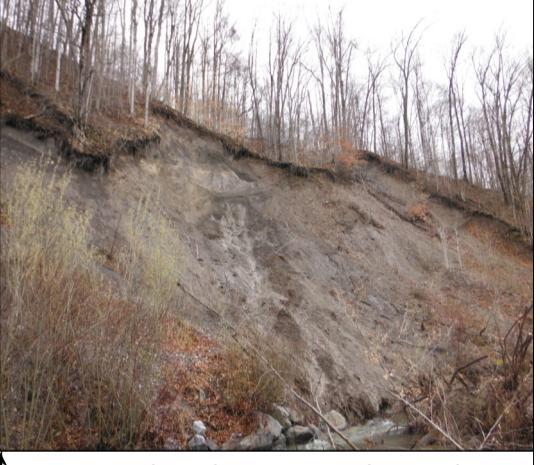
Over time, the Inlet stream velocities have carved into the bottom of this slope near the Tompkins County line, resulting in very

unstable slope conditions.

The Inspection Program removed a problematic tree snag, which was directing energy into the toe of this slope, and applied a special grass mix in an attempt to stabilize the site. Repairs to this site will be ongoing into 2015.

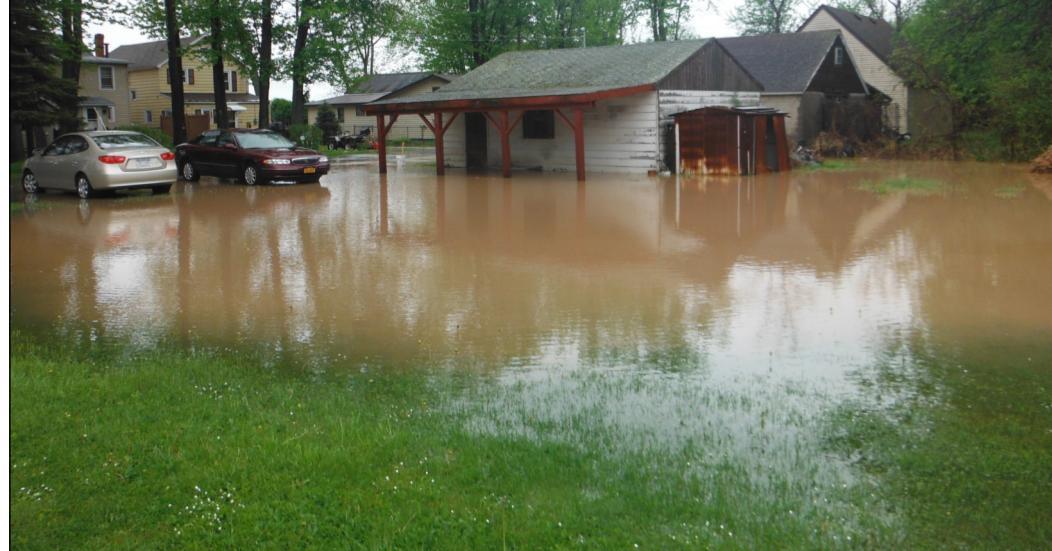
Torrential rain events were frequent during the summer months of 2014. Events during June and July produced flooding on flat, poorly drained areas, typically within close proximity to the lakeshore.

The above photo was taken during a 2" rainfall event at the end of July 2014 on the west shore of Owasco Lake near Mobbs Road in Fleming.

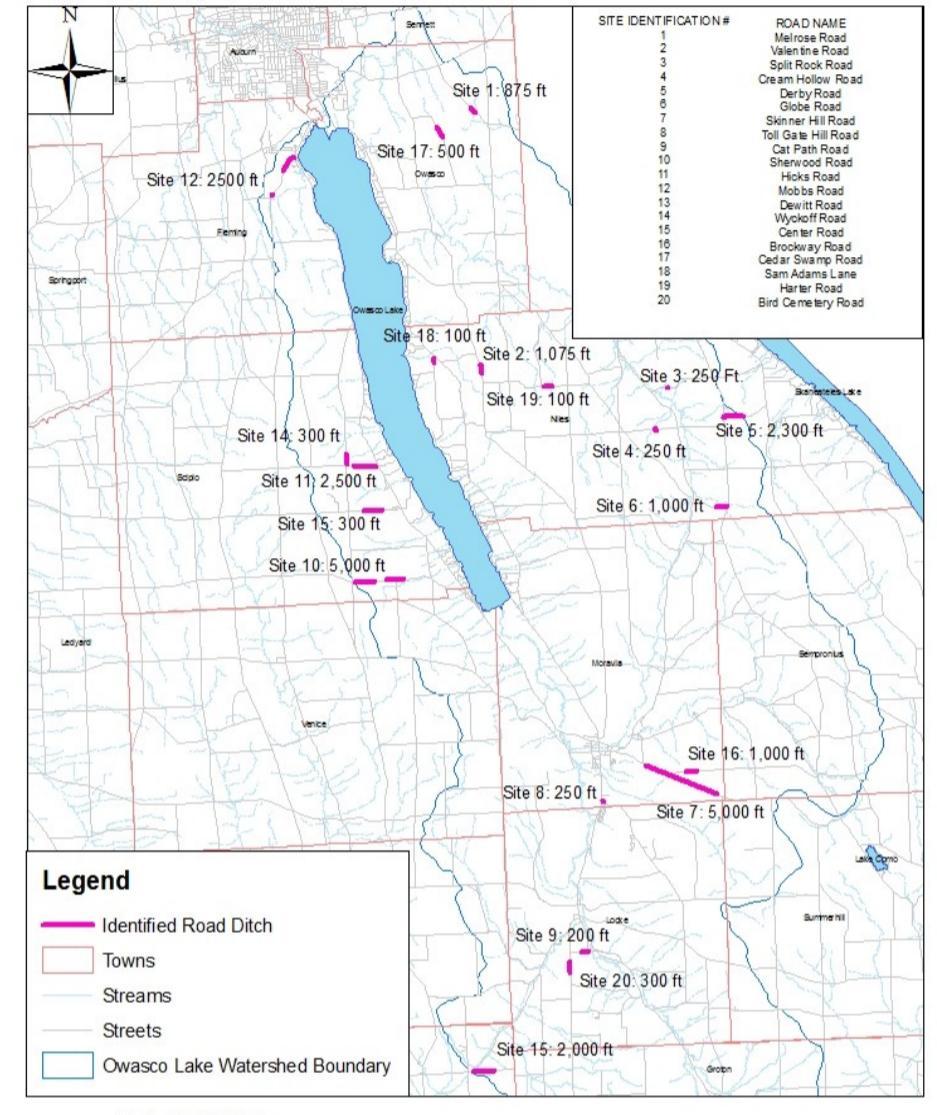
Owasco Lake Watershed Ditch Remediation Sites

Combined Length of Ditches: 26,850 linear ft

The initial assessment, completed by Inspection Staff during the fall of 2014, identified 20 stretches or lengths of ditch within the watershed in need of varying levels of remediation.

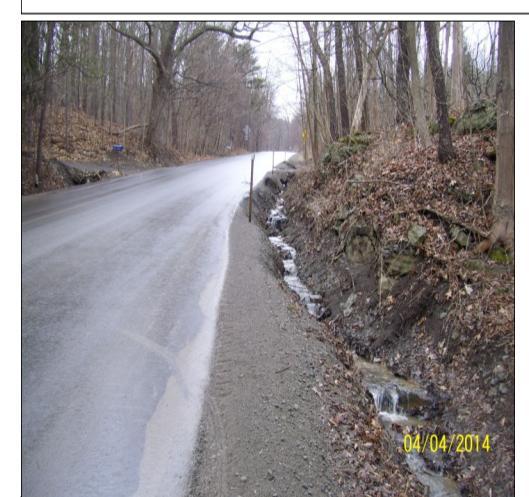
An unstable ditch segment, located in

the southern part of the watershed, encroaches on the newly paved road shoulder during spring 2014. The impacts of ditch erosion can be hazardous for travel and have adverse effects on both environmental and economic levels.

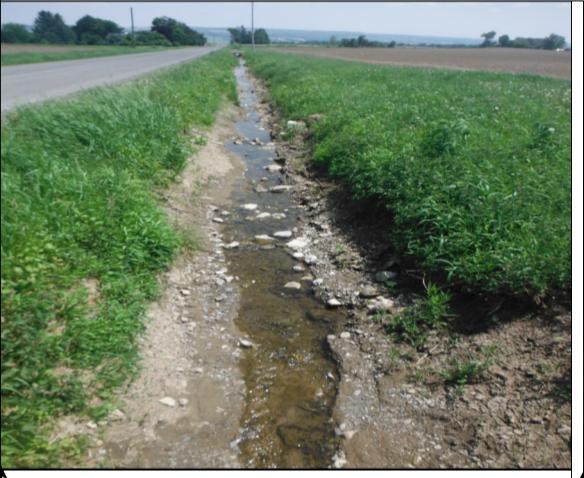
In many locations throughout the Owasco Lake Watershed, it is not uncommon to find road ditches flowing with water, even when the weather is dry.

When ditches act as intermittent streams, it is especially difficult for vegetative 'armor' to establish and stabilize the ditch soils.

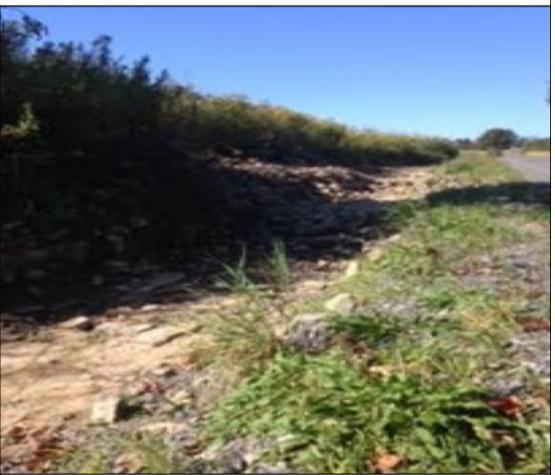
Ditch segments are commonly left unvegetated after cleanout and continuously erode, eventually washing away soils and exposing bedrock or hardpan soils. This process can create a widening of the ditches and often will increase velocities over smooth, exposed rock surfaces.

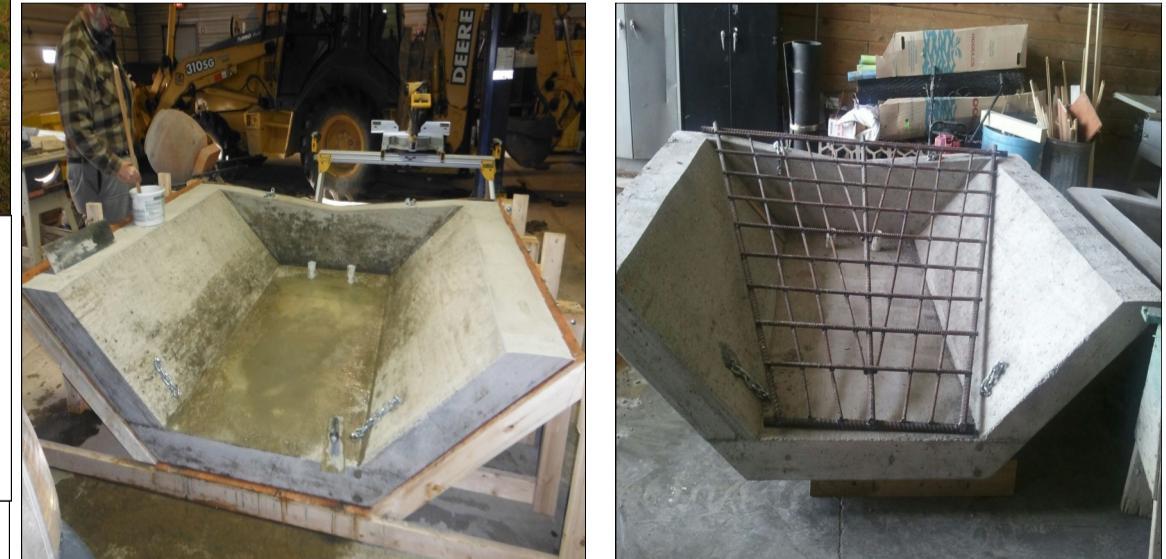
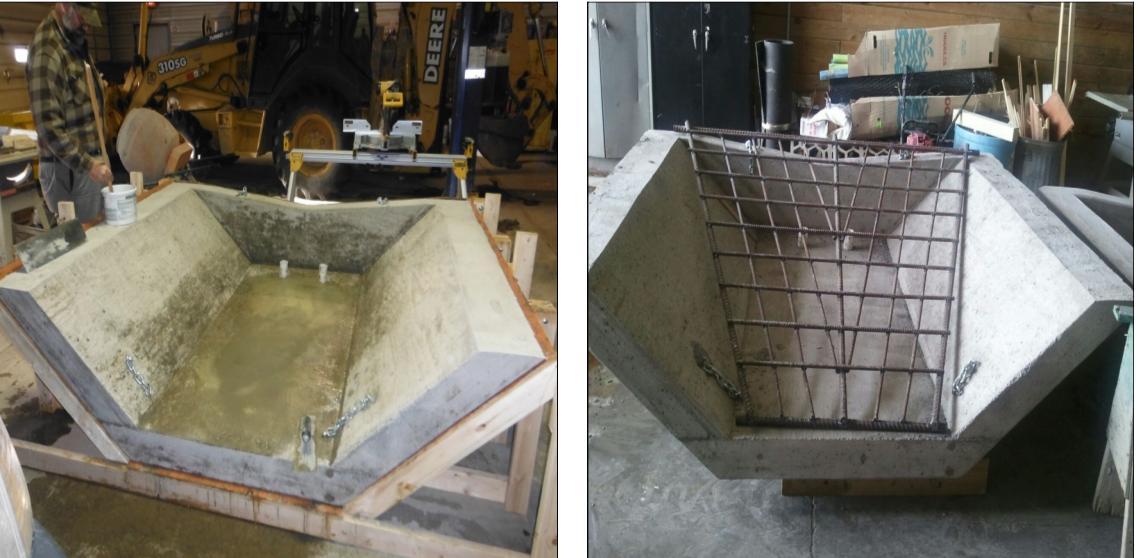
Road Ditch Corrective Actions

Utilizing funds provided by the Emerson Foundation, the Inspection Program and the Cayuga County Soil and Water Conservation District staff constructed a set of concrete sediment traps during the winter months.

By design, these concrete traps will essentially capture nutrient-transporting soil particles and allow for quick, simple cleanout by road crews.

The sediment traps shown above will be deployed and installed at selected locations in the watershed during the spring of 2015.

These traps will be the "pilot" structures to demonstrate the effectiveness of capturing sediments moving through disturbed ditches, showcasing the positive impact they can have on water quality.

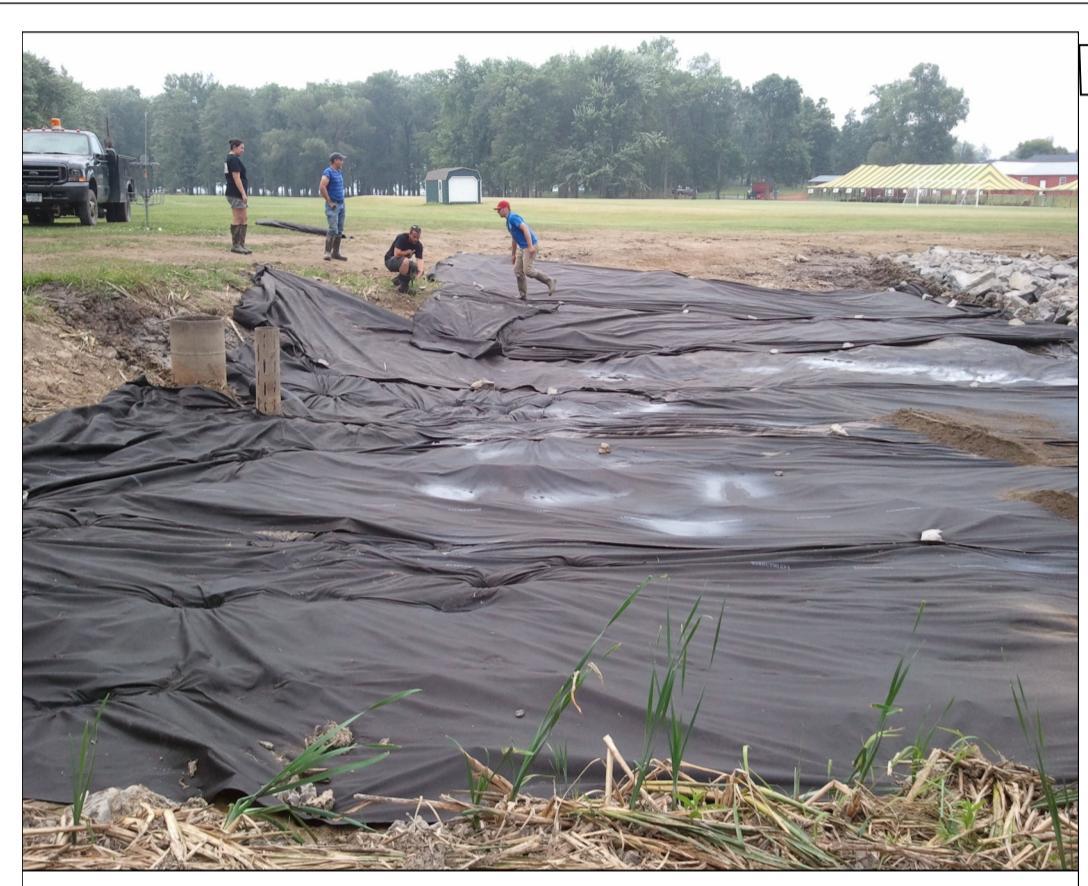
Seasonal Inspectors assist the Cayuga County Soil and Water Conservation District with the reconstruction of stormwater filtration ponds at Emerson Park on the northern edge of Owasco Lake.

The reconfiguration of the ponds for bacteria abatement was funded by the Finger Lakes-Lake Ontario Watershed Protection Alliance (FLLOWPA)

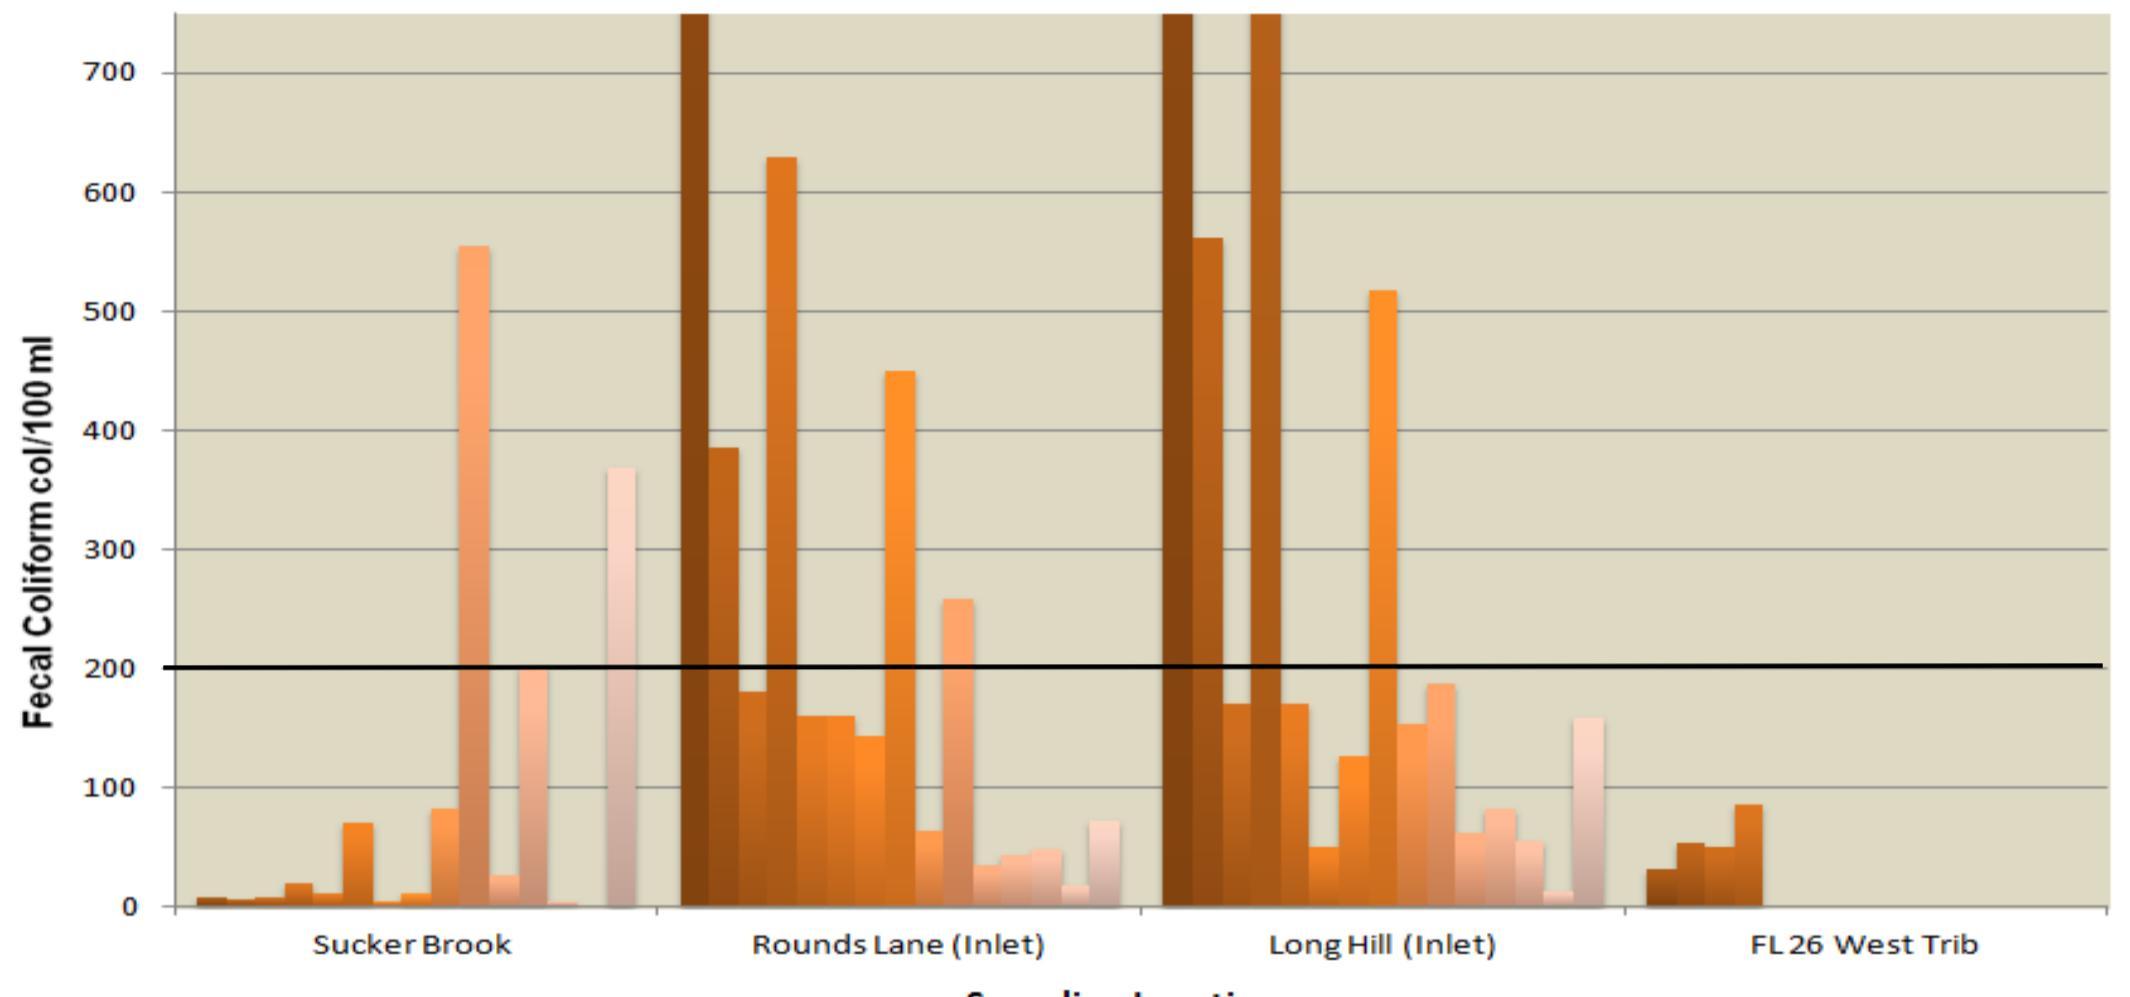
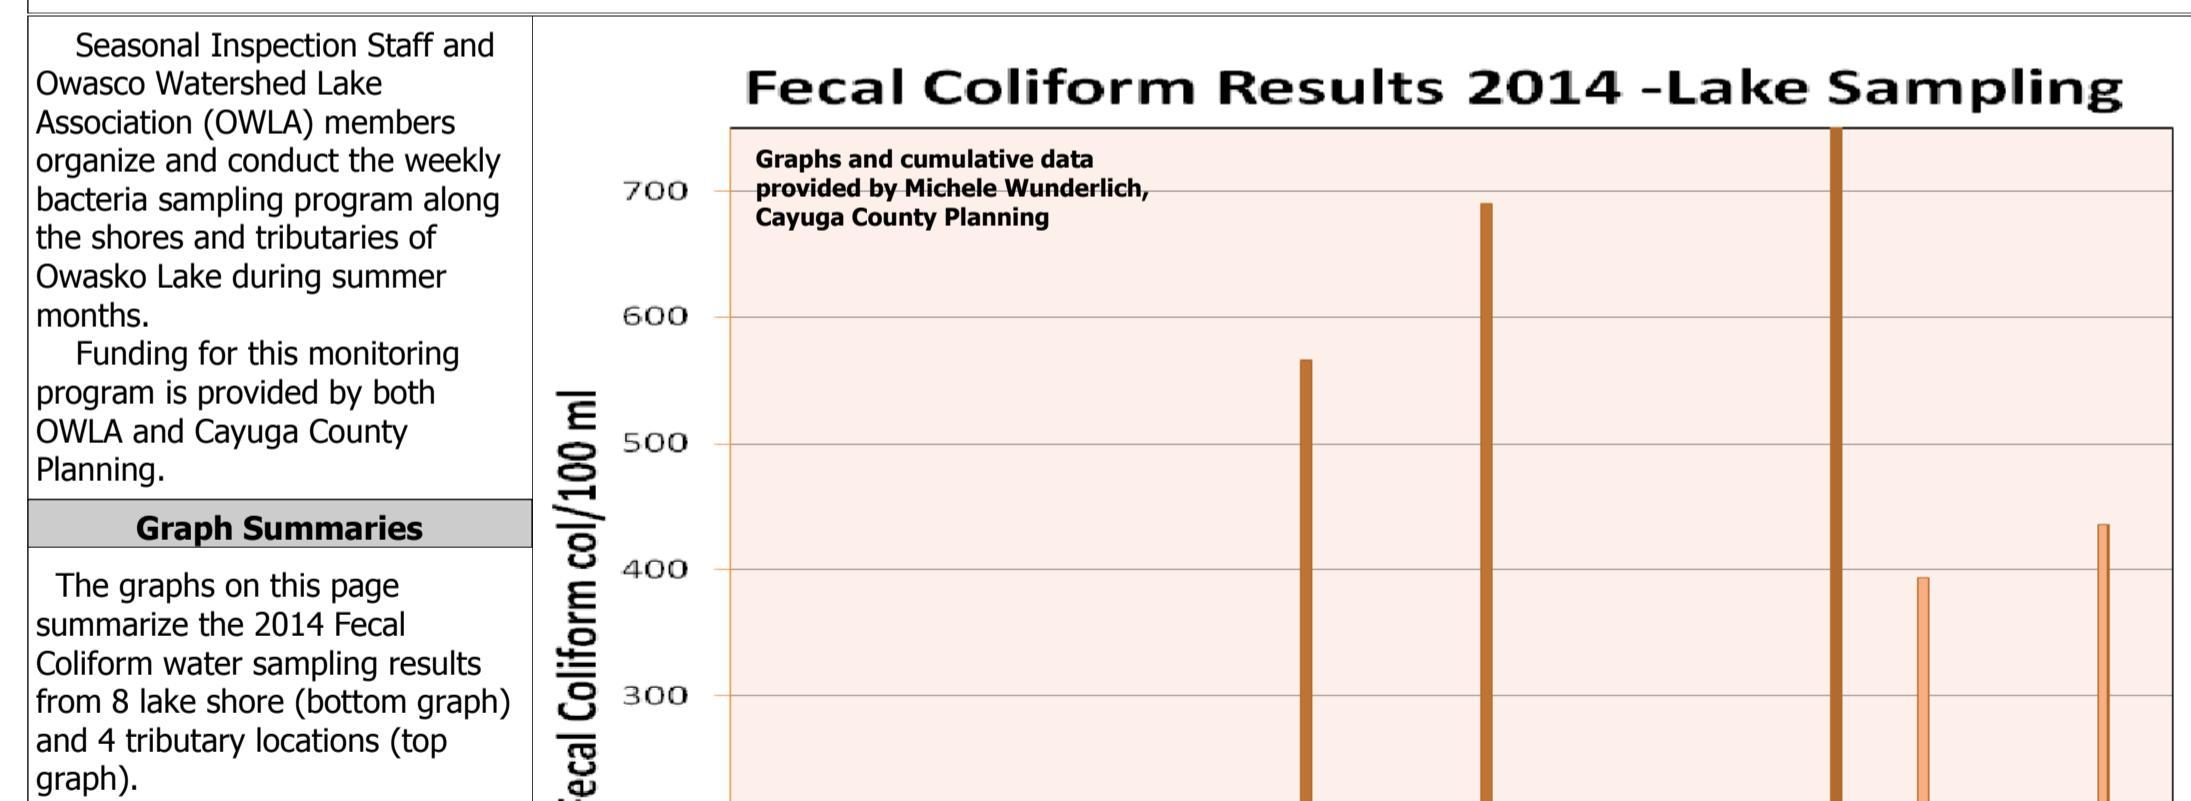
Fecal Coliform Results 2014 Tributary Sampling

The 2014 sampling program included weekly (represented by each vertical bar) testing for total fecal coliform at these locations. Generally, if the results are less than **200 (bold line)** fecal coliform per 100/ml over the course of the summer, the bacterial level means water quality would be considered good and suitable for bathing.

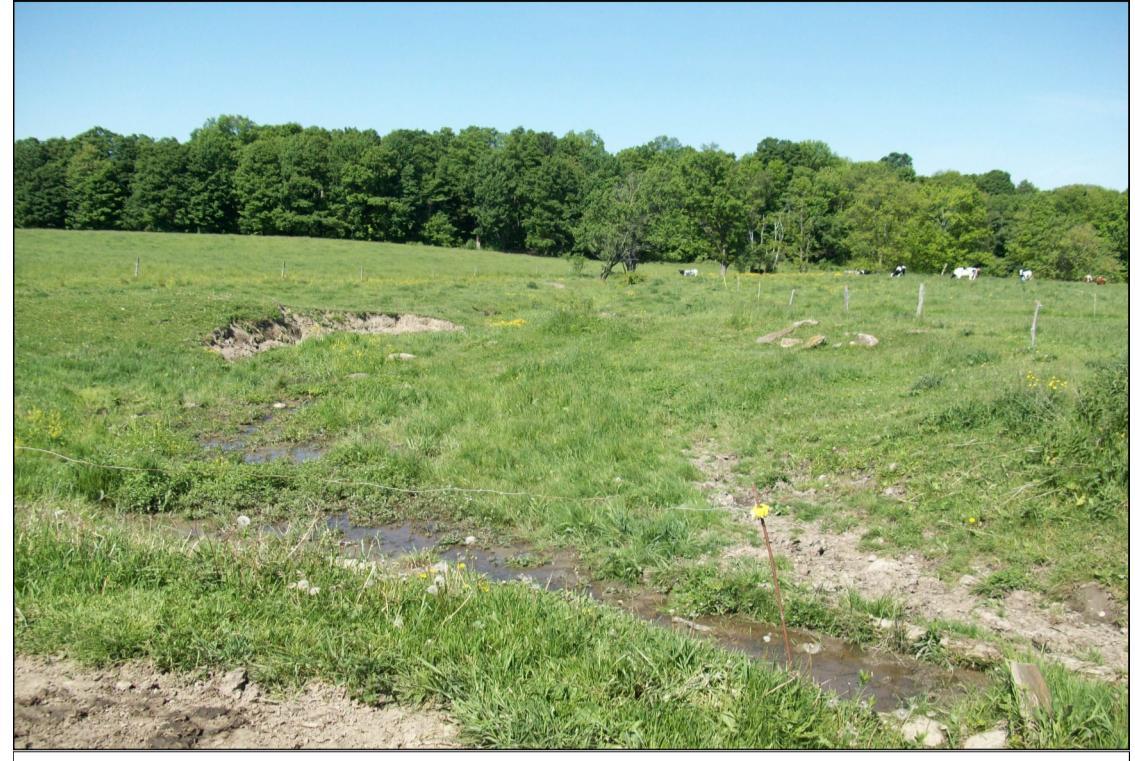
Animals with free access to clean surface water is a violation of the watershed Rules and Regulations.

Large concentrations of animals with access to streams can contaminate surface waters and graze the banks of the streams exposing soils and creating erosion—shown in photo above. To avoid violation, the landowner here worked to fence out the herd, provide a new watering trough and new laneway to pasture, away from the stream.

The Inspection Program continues to assist landowners with correcting these violations, working with landowners and the Soil and Water Conservation District staff on protective measures.

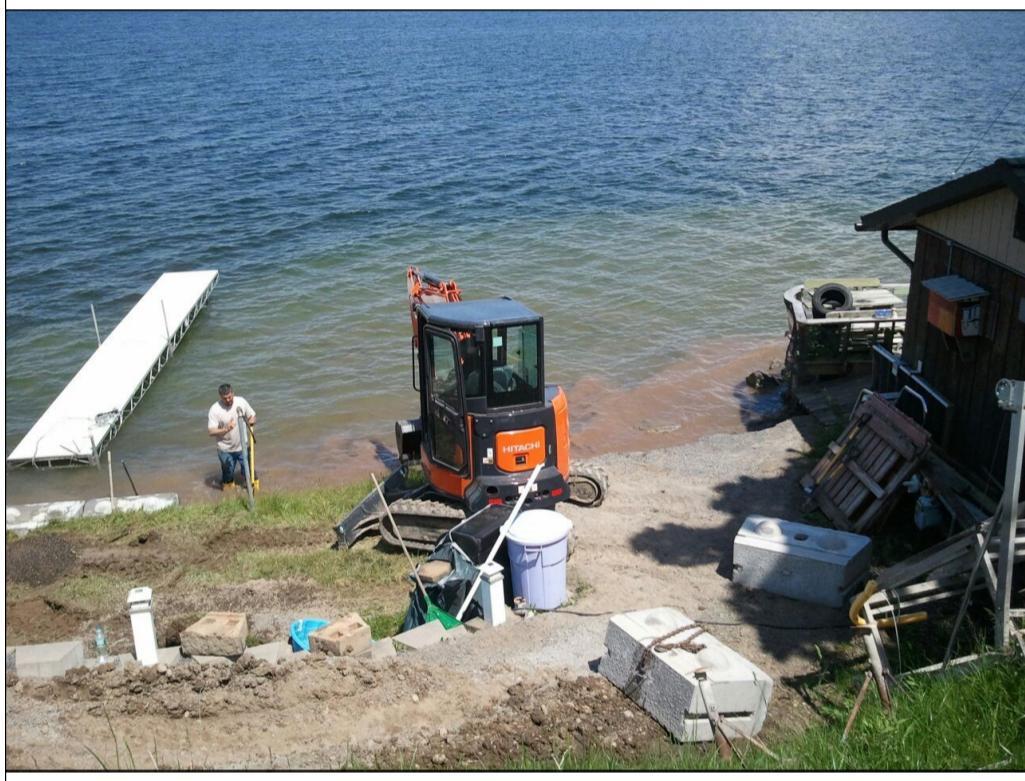
The shoreline construction, occurring adjacent to Owasco Lake during the summer of 2014, resulted in a plume of sediments into the Lake and a water quality violation of NY State water quality standards.

The Inspection Program works directly with the New York State Department of Environmental Conservation to resolve water quality violation on construction sites where an obvious (where there is a contrast in water color) plume or discharge is occurring.

A 'stop work' order <u>and</u> fine (up to \$37,500/day) will be levied on construction sites found to be degrading nearby water quality.
